THE DAVID W. TAYLOR MODEL BASIN

FATIGUE TESTS OF DIESEL ENGINE PISTON RODS
WITH AND WITHOUT SPRAYED METAL COATING

AUGUST 1942

REPORT 493

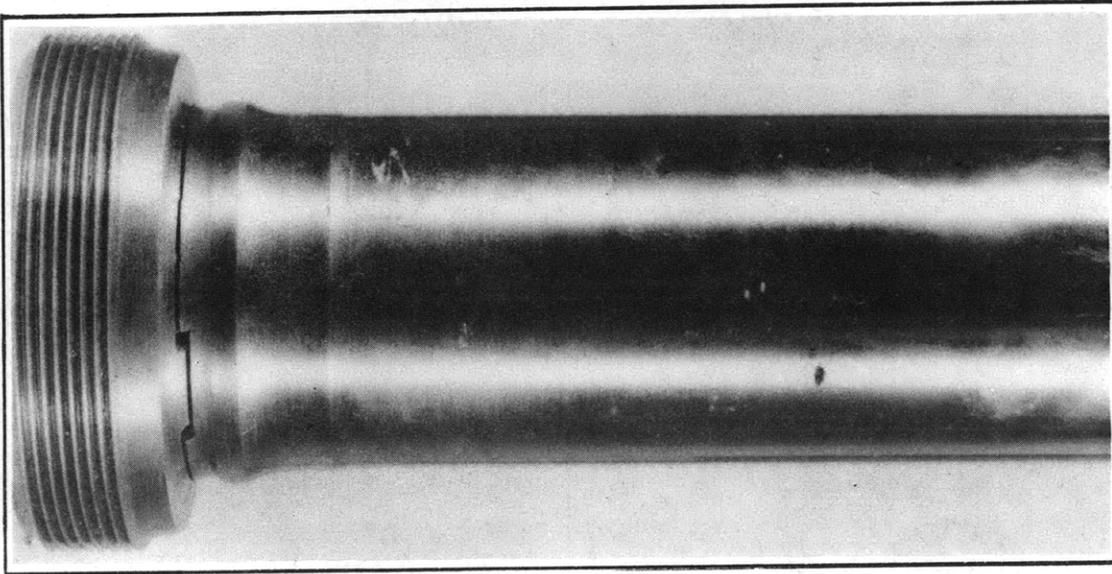
Figure 15 - Specimen N2 after Failure

Failure occurred after 243,232 cycles at a nominal stress range from 22,000 pounds per square inch tension to an equal compression. This failure is typical of most of the rods tested. In general the fatigue cracks followed circumferential tool marks visible before the fatigue tests began.

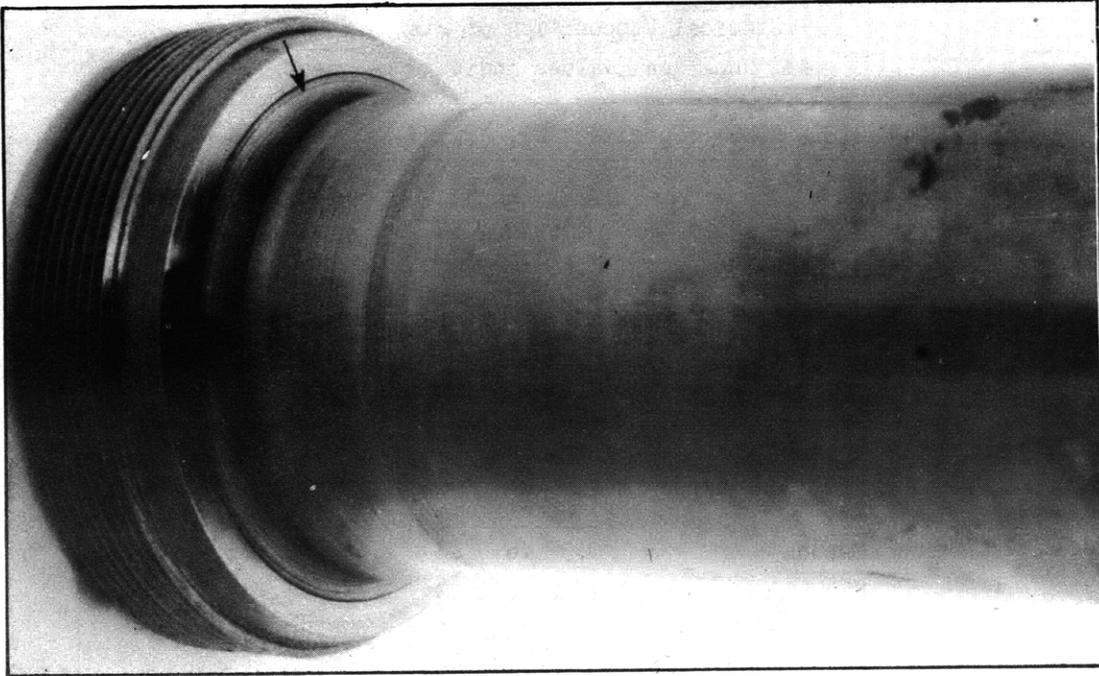
Figure 2 - Piston End of Specimen without Metal Coating before Testing

Note the deep tool marks, especially in the bottom of the radius where the rod flares out. These tool marks are perpendicular to the direction of loading and probably cause local regions of high stress.

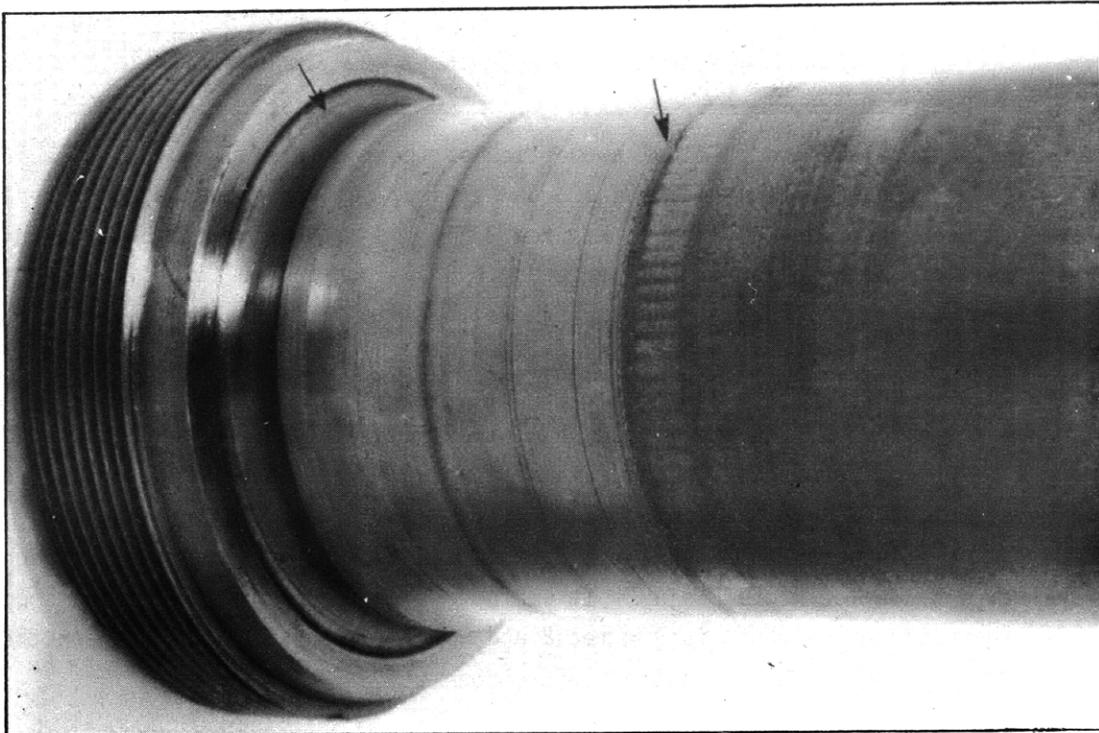
Figure 3 - Piston End of Metal-Coated Specimen before Testing

Note the tool marks as in Figure 2; also the gouge in the metal coating at the top.

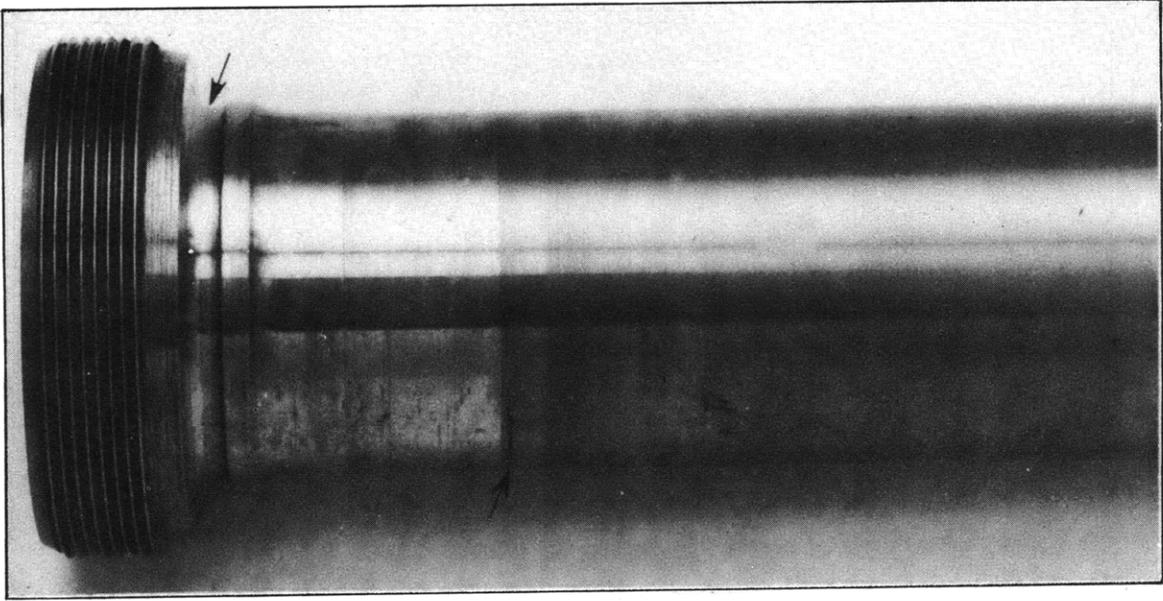
Figure 4 - Piston End of Metal-Coated Rod before Testing

Note the gouge in the metal coated surface. The first fatigue crack developed in the fillet, however, rather than in the gouge.

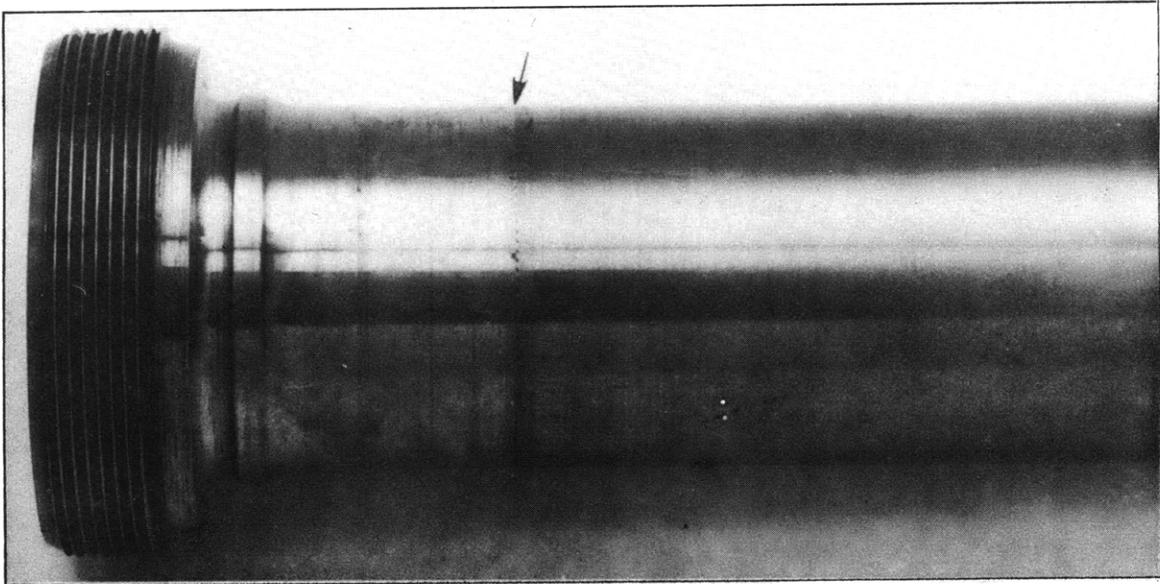
Figure 5 - Piston End of Metal-Coated Rod before Testing

Note the improper finish at the junction of the metal coating and the bare rod.

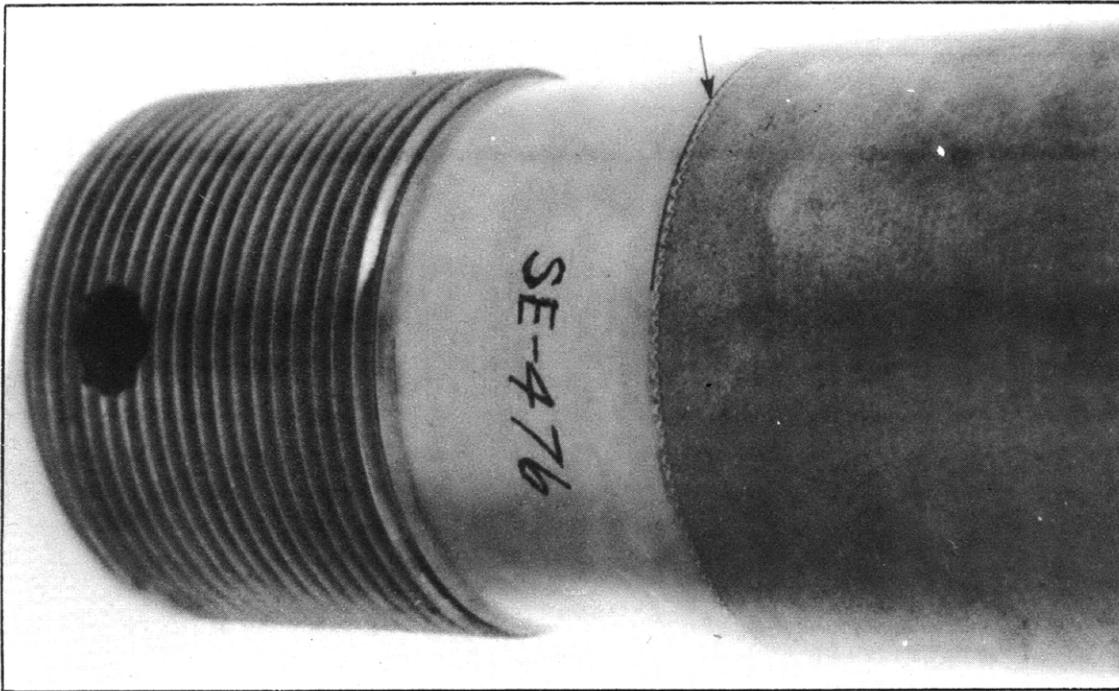
Figure 6 - Crosshead End of Metal-Coated Rod

Note the gouge, knurling, and tool marks. This rod actually failed at the root of the thread as shown in Figure 16.

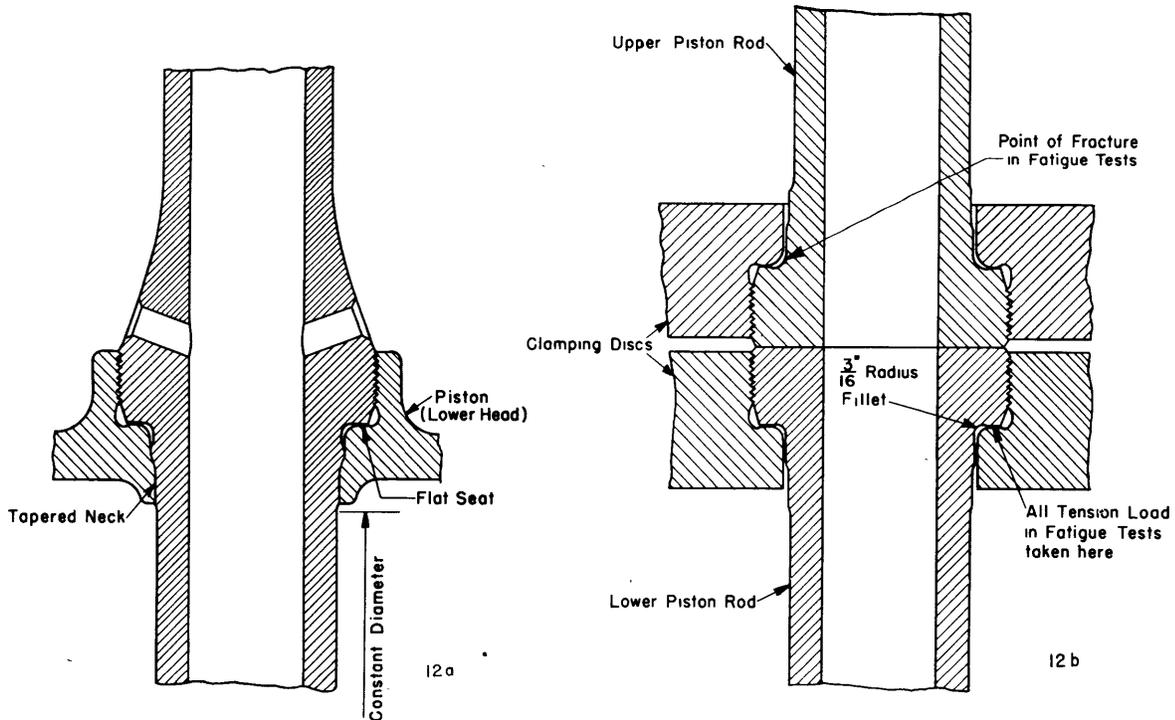
Figure 12 - Methods of Clamping Piston End of Rod in Engine and in Test

A glance at Figure 12 will show that the holding arrangement at the right, corresponding to Figure 11, departed in several essential respects from the arrangement in the engine, shown at the left.

However, in the test assembly of Figure 12b, all the upward load exerted by the disk is taken by the flat face alone. Despite the relatively large radius of the fillet there must be excessive deformation in this region, especially in view of the great disparity in section areas above and below the fillet.

The test arrangement of Figure 12b was approved by the Bureau of Ships before the tests began. After fracture of the first rod in the bottom of the large fillet, a conference was held with Bureau representatives, at which time it developed that the

The method of attaching the lower piston head to the rod is shown at the left; the head bears against a tapered neck as well as against a flat seat.

engine conditions were not being accurately represented, as outlined in the paragraphs preceding. It was decided, however, to continue the tests with the apparatus already built.

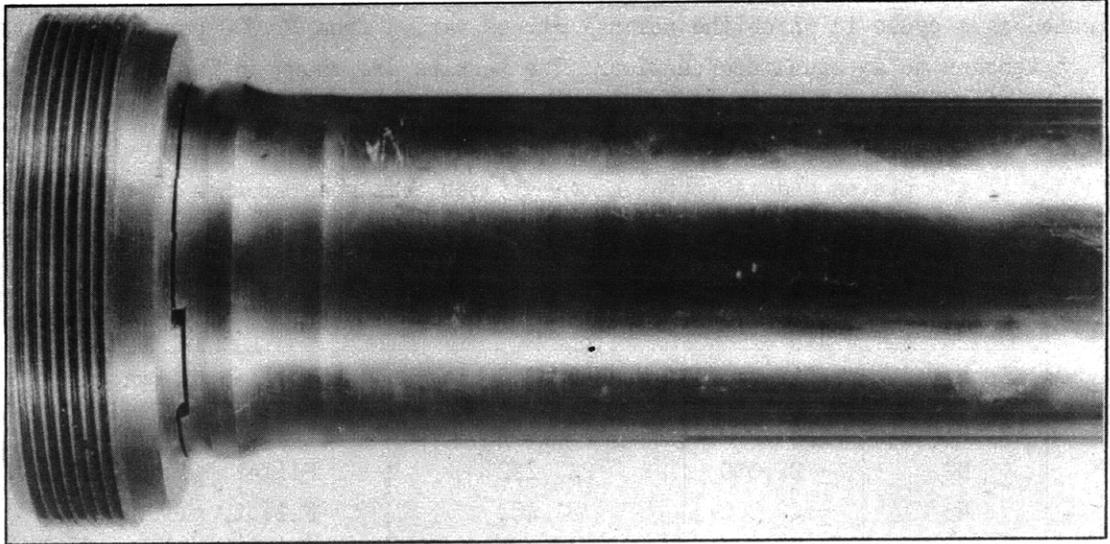
Figure 15 - Specimen N2 after Failure

Specimens N1 and NMC1 were subjected to an alternating load which produced a nominal stress varying from 27,500 pounds per square inch tension to the same stress in compression. Both specimens failed in the radius at the piston end of the rod, in the location indicated in Figure 15. N1 failed at

Failure occurred after 243,232 cycles at a nominal stress range from 22,000 pounds per square inch tension to an equal compression. This failure is typical of most of the rods tested. In general the fatigue cracks followed circumferential tool marks visible before the fatigue tests began.

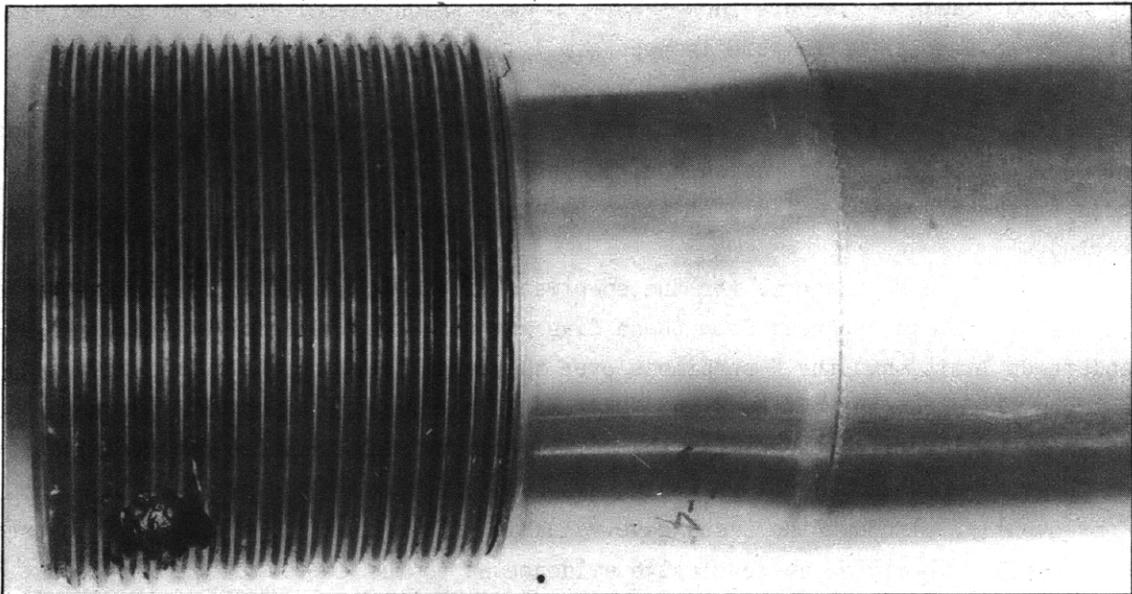
Figure 16 - Specimen NMC2 after Failure

Note that the fatigue crack developed at the base of the last thread at the cross-head end of the rod. All of the other specimens tested failed at the piston end as shown in Figures 15, 18, and 19.

portion of the rod; hence the average stress at this point of failure was approximately 19,000 pounds per square inch. For rod NMC2 which failed at the crosshead end, the area at this point of failure is approximately 21 per cent greater than in the body of the rod because of the smaller bore diameter in this region; hence the average stress at this point of failure was approximately 18,000 pounds per square inch. The maximum stresses at these points, because of the short-radius grooves, is probably far in excess of the average. Failure at these points of stress concentration is not unexpected.

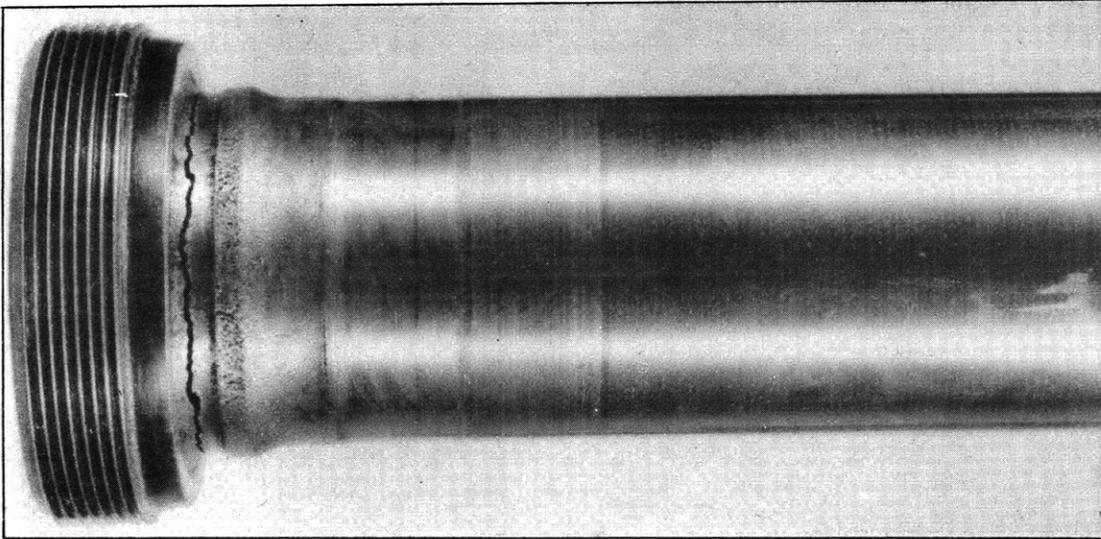
Figure 18 - Specimen UMC2 after Failure

One of the used metal-coated rods, UMC2, failed at a relatively low number of cycles, 159,462. This is explained by the excessive corrosion on this rod, as shown in Figure 18.

This is the piston end of a reclaimed rod. Note the pitting at the left end of the rod, on the enlarged neck and in the large fillet. Whether this is due to the corrosive effects of the products of combustion which leaked under the piston seat, to corrosion fatigue, or to both, has not been determined. This rod is to be compared with the reclaimed rod UMC1 shown in Figure 19. Rod UMC2 withstood only 159,462 cycles whereas UMC1 withstood 699,366 cycles at the same stress of 22,000 pounds per square inch.

Rod UMC2 shown in Figure 18 was badly pitted by corrosion; the corrosion pitting in Rod UMC1 of Figure 19 was less pronounced. Rod UMC2 endured only about one quarter the number of cycles endured by Rod UMC1 before failure. Corrosion pitting evidently greatly reduces the endurance strength of diesel engine piston rods.

1. That used piston rods of double-acting diesel engines be reclaimed by metal-coating provided the corrosion is not too severe. Corrosion-pitted metal should be removed and replaced during the repair operations.
2. That all tested specimens not already inspected be examined by magnaflux survey of the metal-coated area, by micrographs of the sections at either end and in the middle of the rod, and by hardness survey at the same points. The David Taylor Model Basin is not equipped to do this work.
3. That photo-elastic studies be made to determine the stress conditions caused by the special method of clamping the piston ends together.

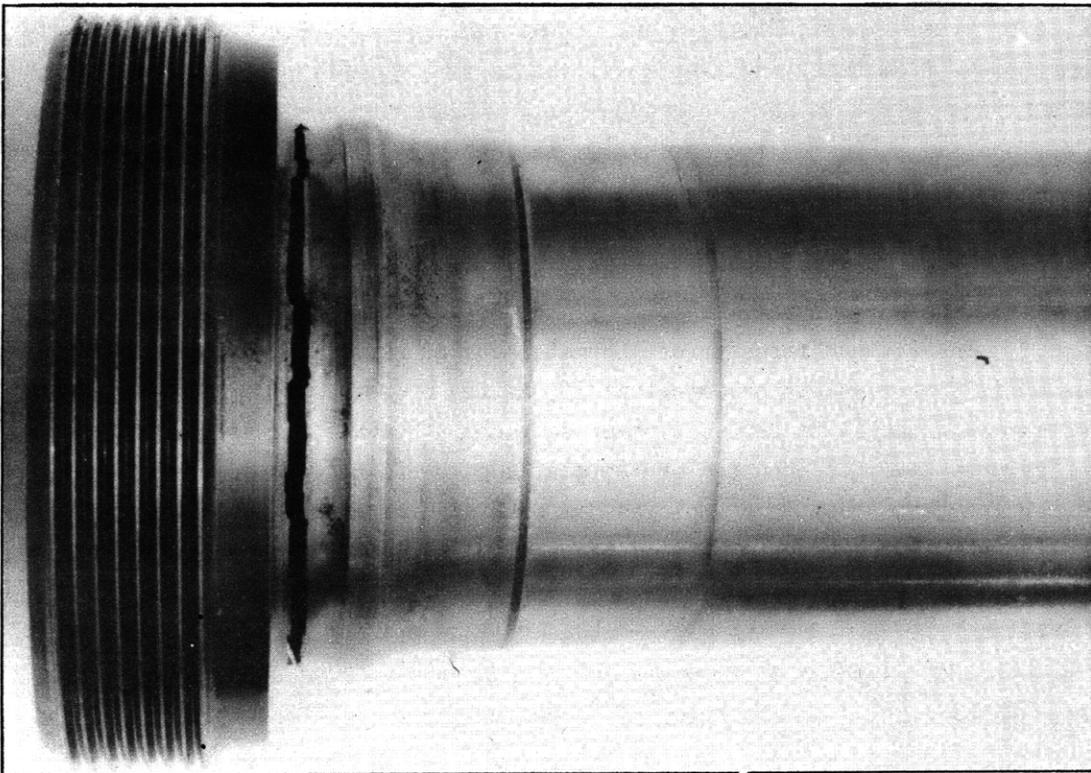
Figure 19 - Specimen UMC1 after Test

This is the piston end of a reclaimed rod. Note that the condition of the surface in way of the tapered neck and the large fillet is better than that of the reclaimed rod shown in Figure 18.
