Memorandum 6M-3940

SUBJECT: RESULTS OF THE SYSTEM TEST (PHASE II) PERFORMED ON THE
AN/FSQ-7 (XD-1) DURING JULY, AUGUST, AND SEPTEMBER 1955

Date: 1 November 1955

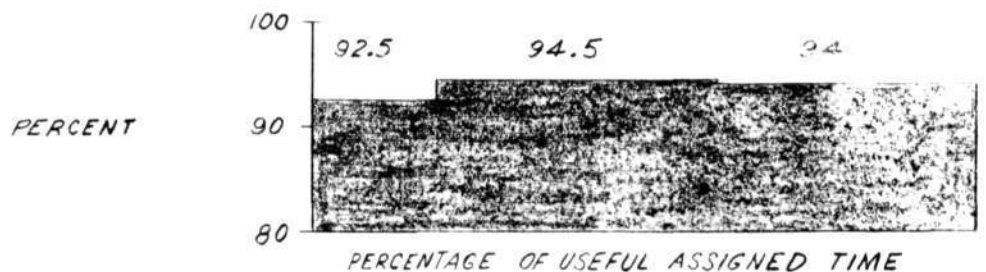
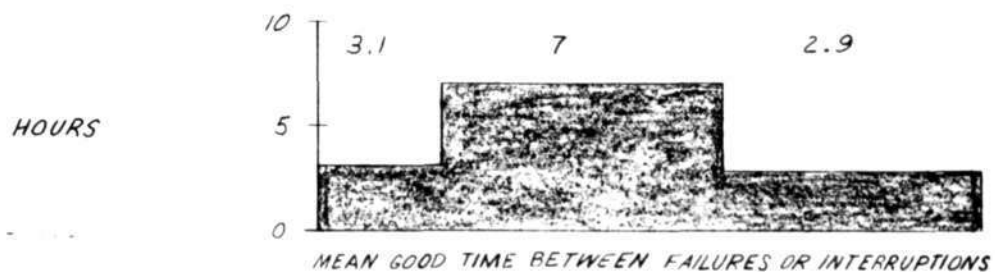
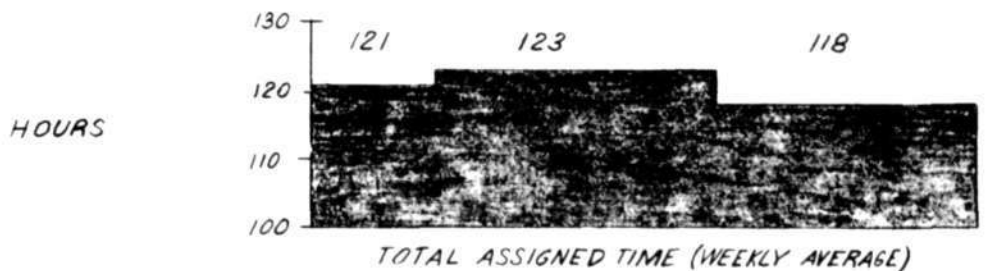
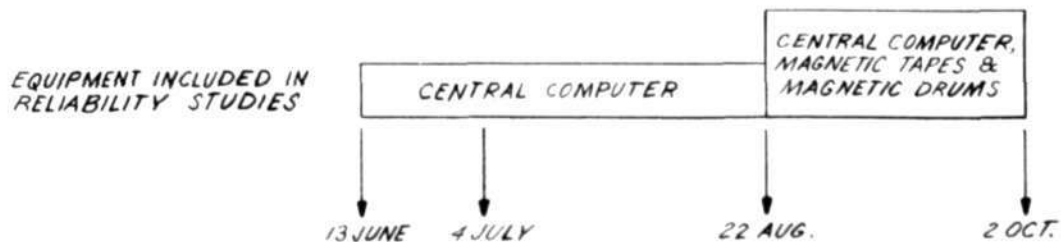
FIG. 1
AN/FSQ-7 (XD-1) RELIABILITY,
13 JUNE 1955-2 OCTOBER 1955

A decrease in reliability was expected when interruptions resulting from drum and tape failures were included in reliability studies. This is evident in the "mean good-time between failures" indication in Fig. I.

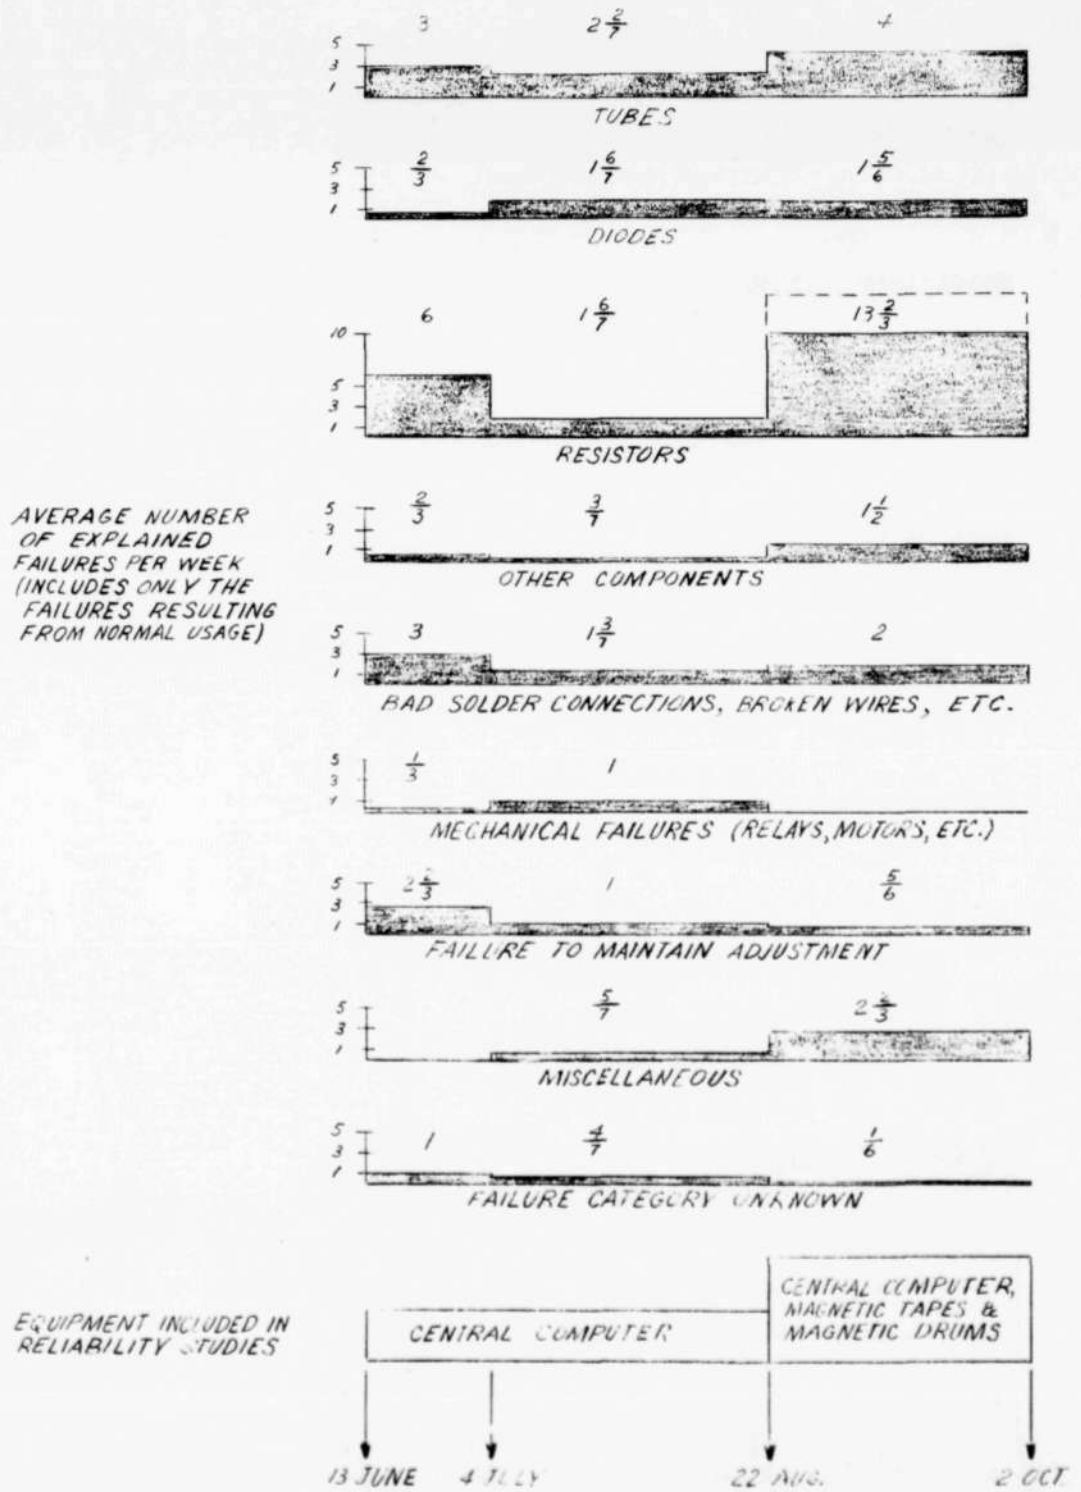
FIG. 2
EXPLAINED FAILURES IN AN/FSQ-7 (XD-1),
13 JUNE 1955 - 2 OCTOBER 1955

A comparison of the results of XD-1 reliability studies for the period including 13 June through 2 October 1955 is summarized in bar-graph form in Figs. I, II and III. The only components which showed excessive failure rates were resistors (see Fig. II). These failures were most prevalent in power cathode follower circuits located in core memory II (frame 10) and the main drum control frame (frame 21).
