FOULING OF SHIPS' BOTTOMS

EFFECT OF PHYSICAL CHARACTER OF SURFACE

APRIL, 1935

REPORT NO. 398

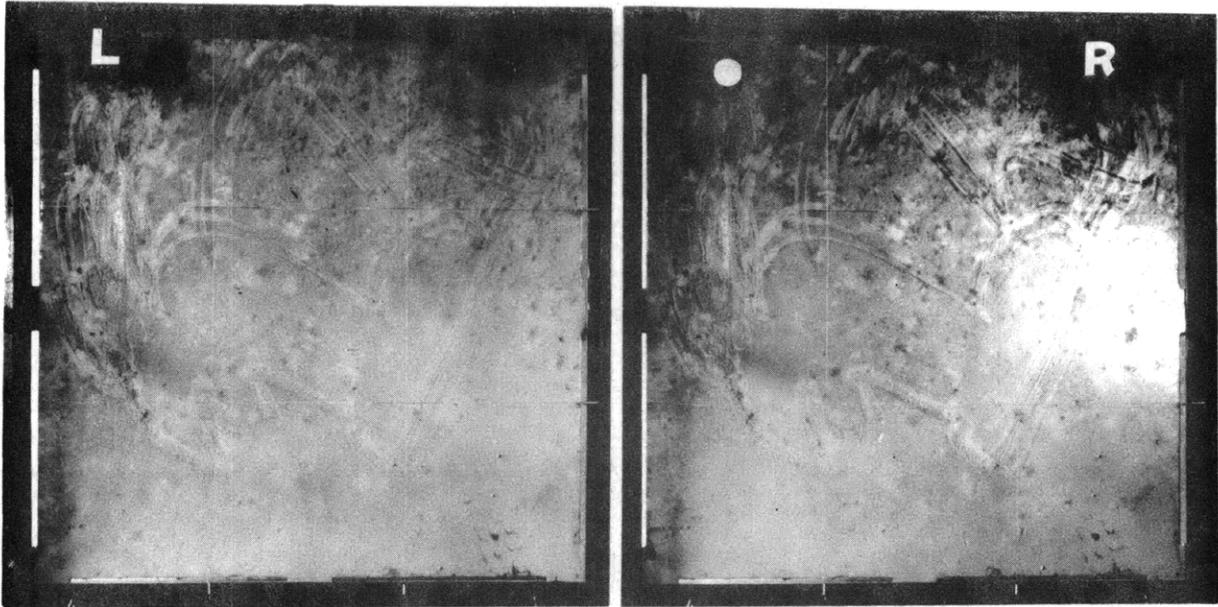
FIGS. 6 and 7. STEREO VIEWS OF POLISHED SURFACE AT THE END OF ONE MONTH'S SUBMERGENCE. 5 July, 1934.

Figs. 6, 7, 8 and 9 were made on 5 July 1934 and show the test panel after 1 month's submergence. The observations made by the Norfolk Navy Yard at this period were:

Polished side: There were a few small barnacles but no rust in this side. A light slime covered the surface.

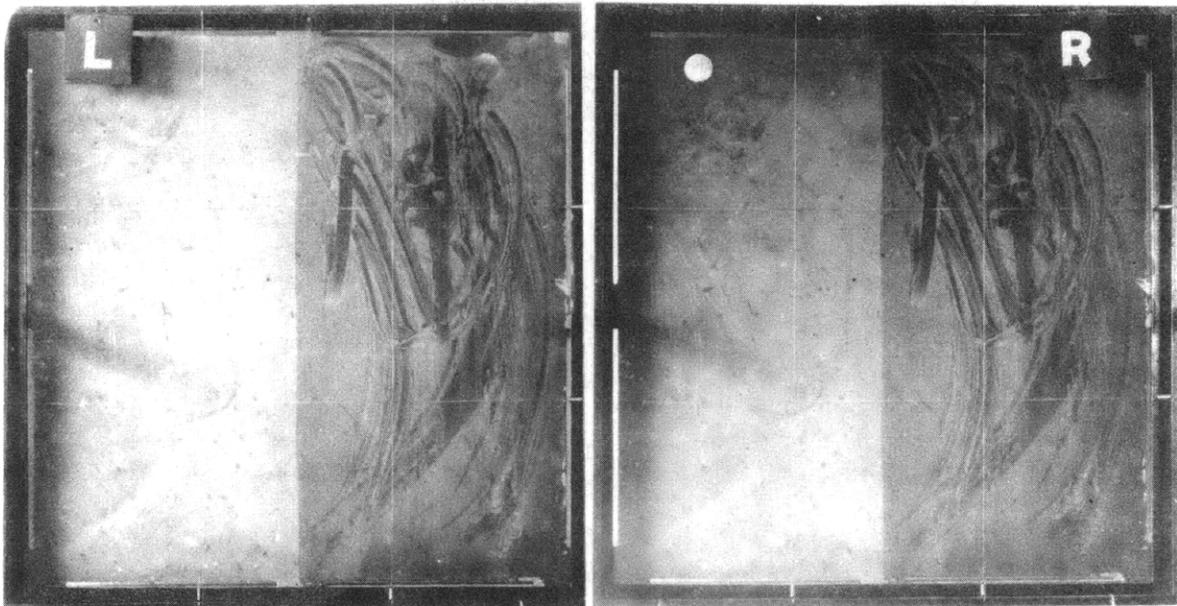
FIGS. 8 and 9. STEREO VIEWS OF UNPOLISHED SURFACE AT THE END OF ONE MONTH'S SUBMERGENCE. 5 July, 1934. The right halves show the painted portion.

Painted side: No shell fouling or rust on painted section and the film was in excellent condition. On the unpainted section there were a few small barnacles but no rust. There was a light slime over the entire panel.

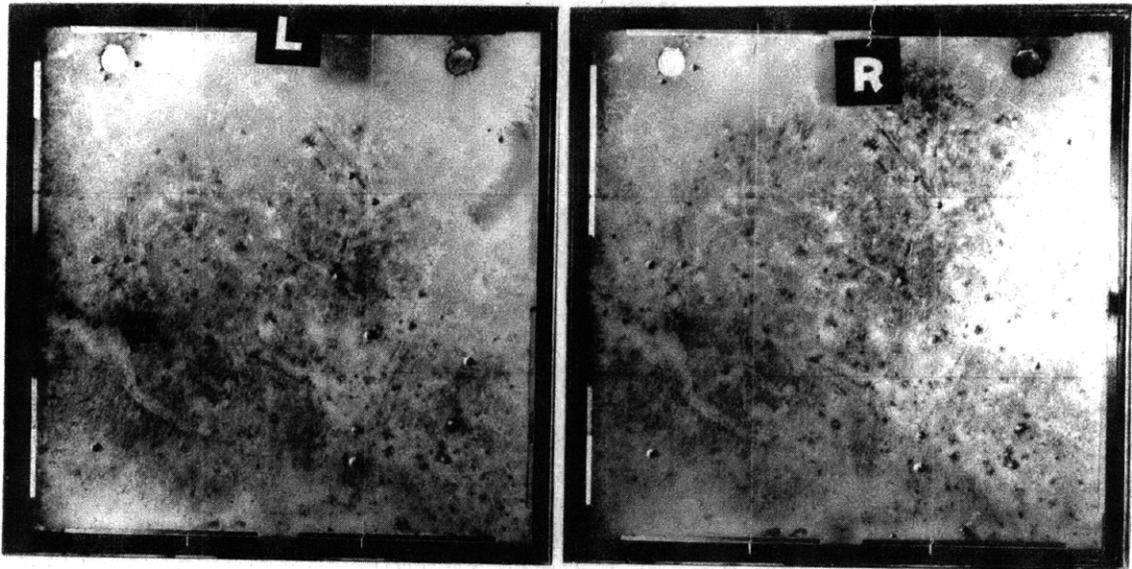
FIGS. 10 and 11. STEREO VIEWS OF POLISHED SURFACE AT THE END OF TWO MONTHS' SUBMERGENCE. 1 August, 1934.

Polished side: There were sixteen barnacles ranging in diameter from 1/4 inch to 1/2 inch, six about 1/8 inch diameter, and a few smaller. Fouling grade 90.

There was a light slime over the panel. The only corrosion was that from the medium steel sister hooks used to suspend the panel under water.

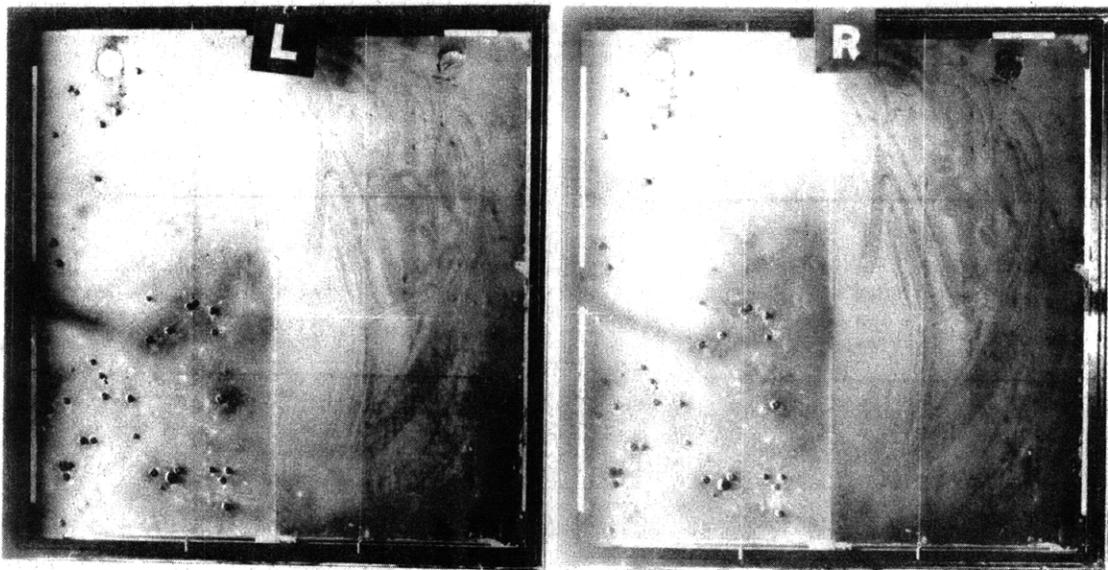
FIGS. 12 and 13. STEREO VIEWS OF UNPOLISHED SURFACE AT THE END OF TWO MONTHS' SUBMERGENCE. 1 August, 1934. The right halves show the painted portion.

Painted side: The painted section was covered with slime but there was no shell fouling. Fouling grade 98. The paint film is cracked (vertically). On and near the edges there are bare spots due to abrasions when fitting panel in frame at previous inspections. The unpainted half had thirty barnacles ranging in diameter from 1/8 inch to 1/4 inch, twelve ranging in diameter from 1/4 inch to 1/2 inch, and a light spray of smaller barnacles. Fouling grade 75.

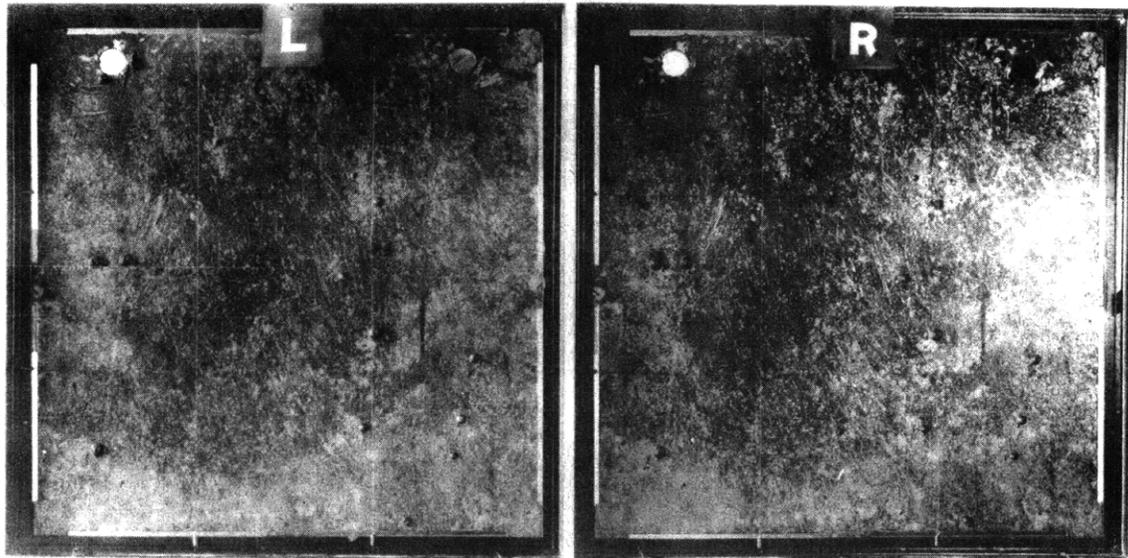
FIGS. 14 and 15. STEREO VIEWS OF POLISHED SURFACE AT THE END OF THREE MONTHS' SUBMERGENCE. 31 August, 1934.

Polished side: There were 13 *Balanus* barnacles about 1/2 inch in diameter, 12 about 1/16 inch in diameter, and a light layer of silt. The fouling grade was 80.

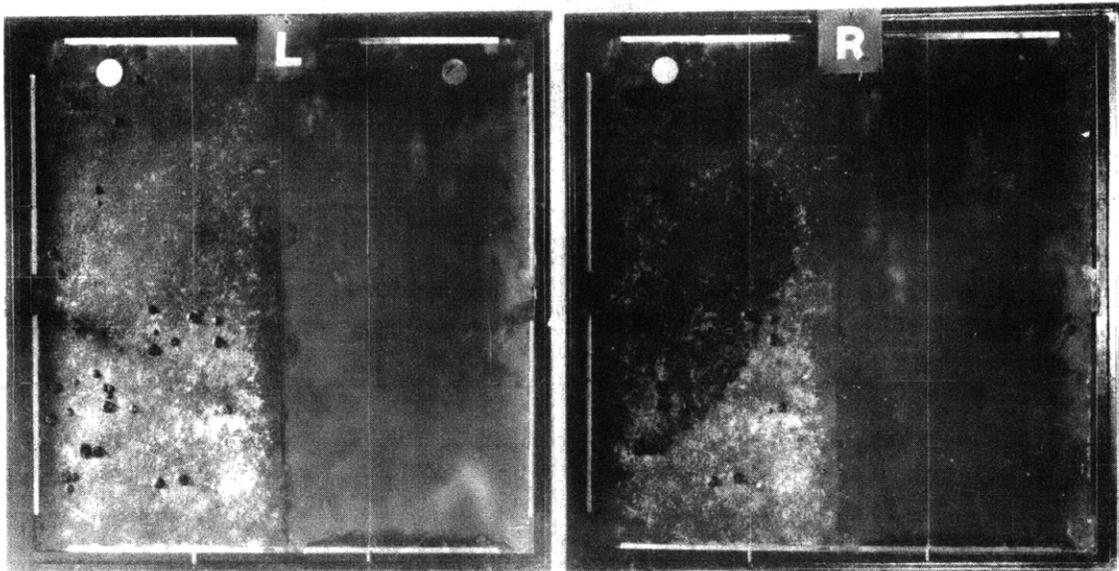
FIGS. 16 and 17. STEREO VIEWS OF UNPOLISHED SURFACE AT THE END OF THREE MONTHS' SUBMERGENCE. 31 August, 1934. The right halves show the painted portion.

Painted side: The painted section had no fouling on it except light silt and was graded 98 as to fouling. There was no corrosion except "run downs" from steel hook holding panel in water. The paint film showed a few abrasions from handling and was thin, eroded. The grade assigned for film conditions was 85. The unpainted section had 28 *Balanus* barnacles 1/2 to 3/4 inch in diameter, 21 about 1/4 inch in diameter and numerous smaller (embryo) barnacles, a few 1/2 inch long hydroids and a light layer of silt. The fouling grade was 60. There was no corrosion from the panel.

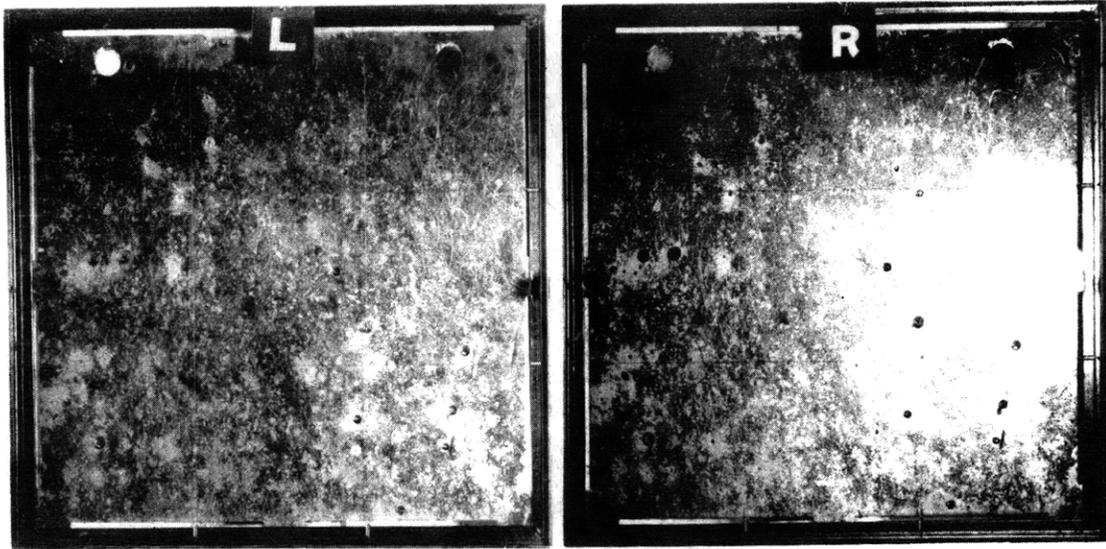
FIGS. 18 and 19. STEREO VIEWS OF POLISHED SURFACE AT THE END OF FOUR MONTHS' SUBMERGENCE. 26 September, 1934.

Polished side: There were 18 *Balanus* barnacles 1/4 inch to 3/4 inch in diameter and many (21 counted) smaller ones. A grade of 75 was assigned for fouling. There was no corrosion on the panel.

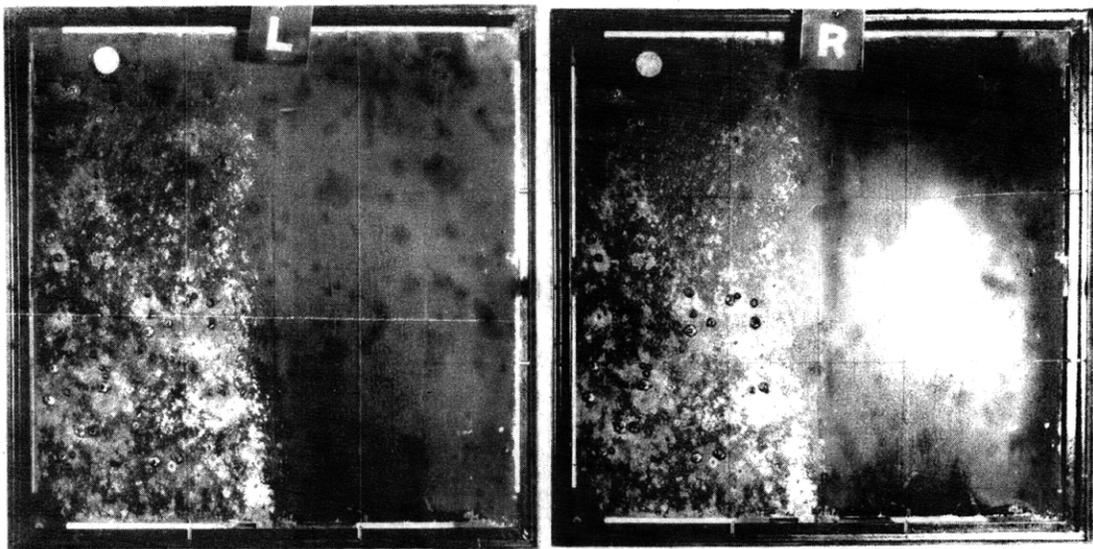
FIGS. 20 and 21. STEREO VIEWS OF UNPOLISHED SURFACE AT THE END OF FOUR MONTHS' SUBMERGENCE. 26 September, 1934. The right halves show the painted portion.

Painted side: The painted section had no fouling except a light layer of silt and was graded 98 for fouling. There was no corrosion except "run downs" from hooks. The paint film was scarred near edges and was thin. It was graded 80. The unpainted section had 39 *Balanus* 1/4 inch to 3/4 inch in diameter and numerous (22 counted) smaller ones. A grade of 60 for fouling was assigned. There was no corrosion of the panel.

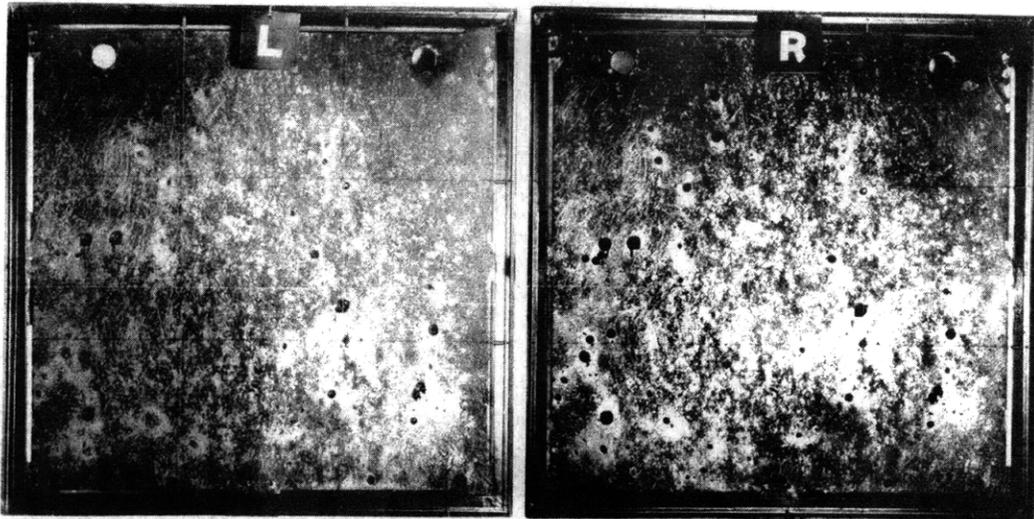
FIGS. 22 and 23. STEREO VIEWS OF POLISHED SURFACE AT THE END OF FIVE MONTHS' SUBMERGENCE. 24 October, 1934.

Polished side: There were 36 *Balanus* barnacles 1/4 inch and larger in diameter and 75 to 100 smaller ones. A grade of 70 was assigned. There was no corrosion from the panel.

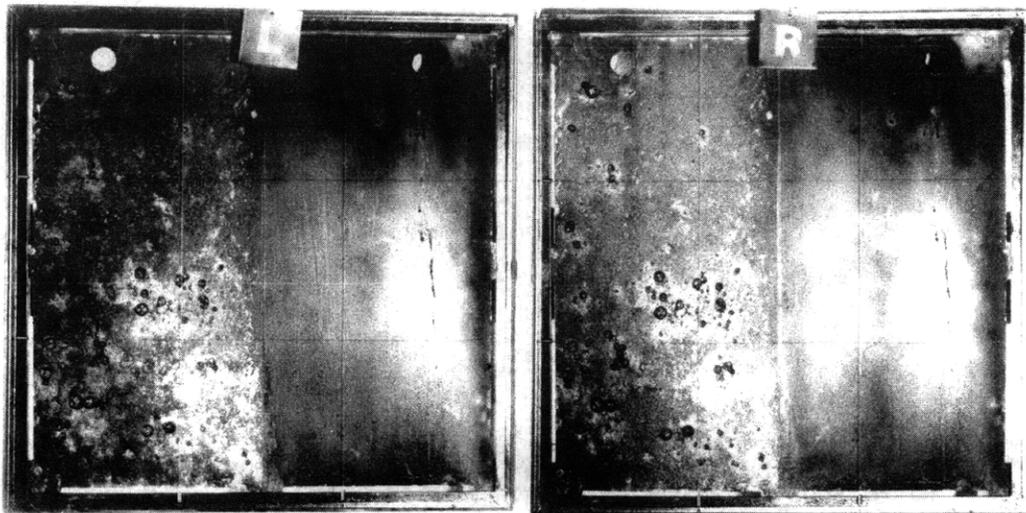
FIGS. 24 and 25. STEREO VIEWS OF UNPOLISHED SURFACE AT THE END OF FIVE MONTHS' SUBMERGENCE. 24 October, 1934. The right halves show the painted portion.

Painted side: The painted half had no fouling except silt. Grade 95 for fouling was assigned. There was no corrosion from the panel. The paint film was off around edges (scars from handling) and was quite thin. The film showed "silking" - numerous, short, vertical "checks". A merit grade of 80 for the film was assigned. On the unpainted half there were 40 *Balanus* barnacles 1/4 inch and larger in diameter and about 100 smaller ones. A grade of 50 was assigned for fouling. There was no corrosion from the film.

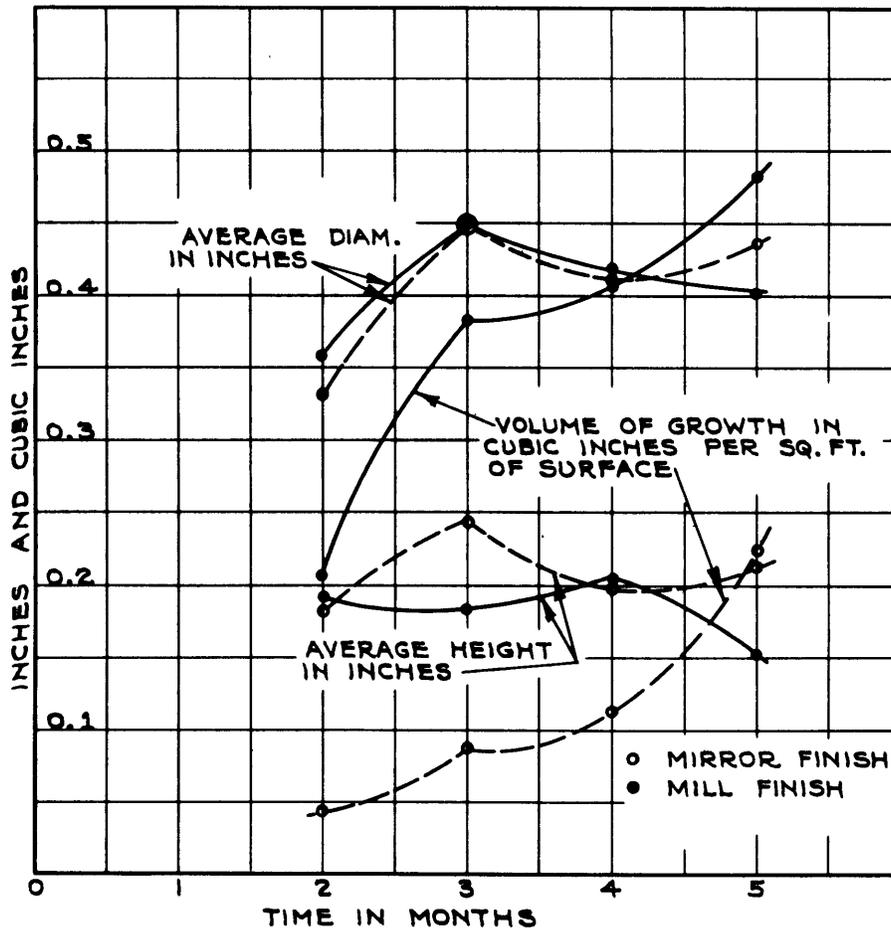
FIG. 28 VARIATION OF AVERAGE HEIGHT, DIAMETER, AND VOLUME OF GROWTH OF BARNACLES WITH AGE

With reference to Fig. 28, it should be observed that the curves, as drawn, are not exact. That is to say, all points on each curve have been connected primarily for purposes of identification. No doubt some experimental errors may be included which will account for apparent changes in direction of the curve. However, disregarding these variations, the spots do indicate, in general, the trend of the curve. The curve giving the average diameter of the barnacles is fairly representative of actual conditions. On the other hand, the average height curve is subjected to some error. It was not possible to measure the height of barnacles with any consistent degree of accuracy because of the presence of silt and slime on the surfaces. The utilization of the cross wires or grid as a base plane for reference of all measurement normal to the surface did not prove entirely satisfactory because of the great area of exposed portions between the grids, and the impossibility of maintaining exactly the space picture of an objective for transfer-

Despite these limitations, the curves given in Fig. 28 are indicative of fouling characteristics. The fouling growth on the unpainted or mill finish surface is, as shown, fairly close to a straight line. This is indicative of a constant accelerated rate of growth. The polished surface, however, indicates a slow initial growth followed, apparently, by an increasing accelerated growth. As between the two, the rate of growth on the polished surface is approximately one quarter of that experienced on the unpainted or mill finish surface.
