VELOCITY OF WATER CURRENTS
IN
U. S. EXPERIMENTAL MODEL BASIN

U. S. EXPERIMENTAL MODEL BASIN
NAVY YARD, WASHINGTON, D. C.

JUNE, 1931.

REPORT NO. 304.

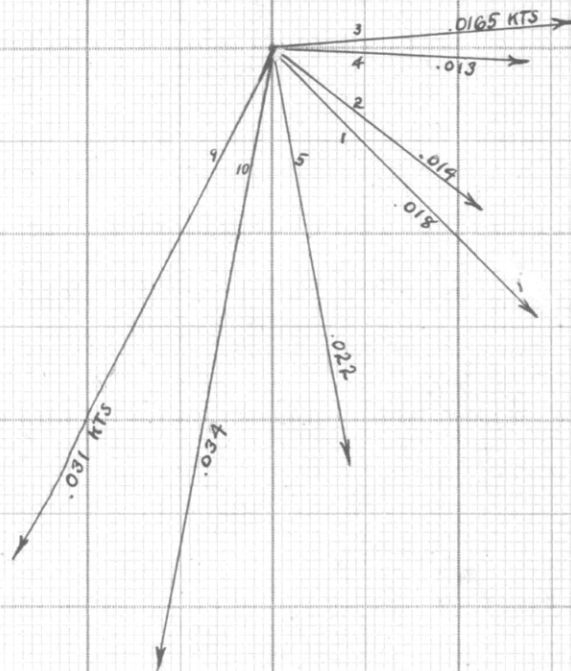
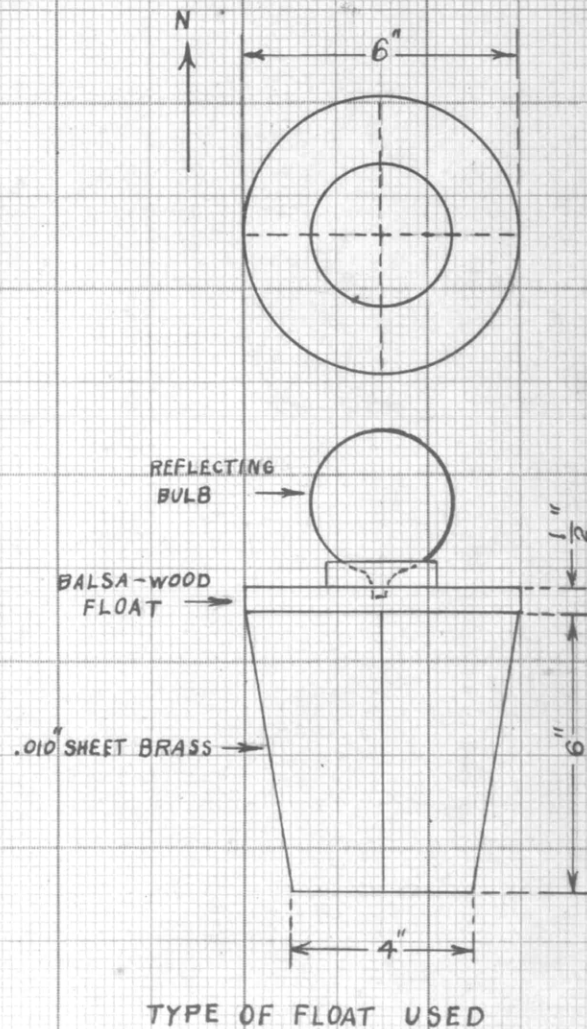
VELOCITY & DIRECTION OF WATER CURRENTS IN MODEL BASIN

SCALE 1" = .01 KNOTS MODEL 2193 CARRIAGE RUNNING AT 5 MINUTE INTERVALS JAN 8, 1931
 NO 6 OUT OF RANGE OF CAMERA NO 7 & 8 UNINTELLIGIBLE STATION 300

VELOCITY OF CARRIAGE ON PREVIOUS RUN

NO 1	3.54 KNOTS
2	3.64
3	3.90
4	4.20
5	4.43
9	5.53
10	5.80

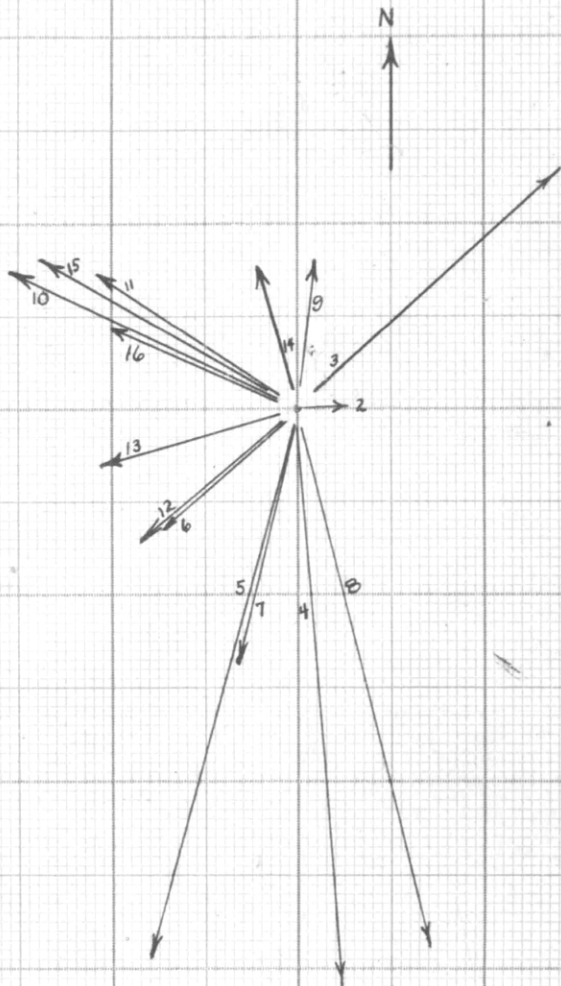
VELOCITY OF WATER IN BASIN
 FEB 2, 1931 MODEL 2285 PROPELLER 914
 SCALE 1" = .01 KTS Station 300
 Carriage running at irregular intervals
 PICTURES TAKEN EVERY 5 SEC. FROM START
 OF CARRIAGE TILL AFTER IT HAD PASSED

NO. OF PICTURE	SPEED OF CARRIAGE PREVIOUS RUN KTS	WATER VELOCITY KTS
1		N.G
2	3.45	.0027
3	1.64	.0189
4	1.74	.031
5	1.88	.030
6	1.97	.010
7	2.10	.014
8	2.25	.030
9	2.50	.008
10	2.55	.017
11	2.67	.013
12	2.71	.011
13	2.94	.011
14	3.20	.008
15	3.08	.016
16	3.08	.011

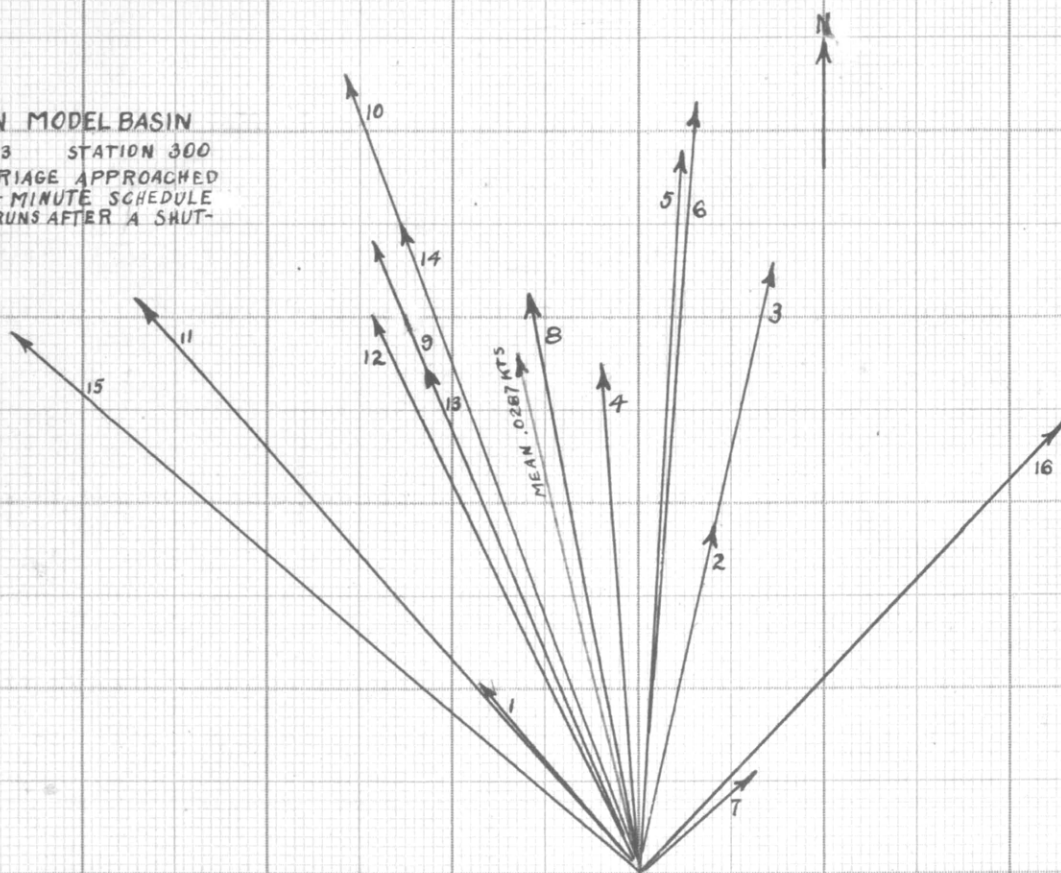
WATER CURRENTS IN MODEL BASIN

FEB 3, 1931 MODEL 3083 STATION 300
 PICTURE TAKEN AS CARRIAGE APPROACHED
 CARRIAGE RUNNING ON 4 MINUTE SCHEDULE
 NO 1 & 7 ARE THE SECOND RUNS AFTER A SHUT-
 DOWN.

N° OF PICTURE	SPEED OF CARRIAGE PREVIOUS RUN KTS	WATER VELOCITY KTS
1	3.65	.0133
2	3.67	.0194
3	3.64	.0333
4	3.64	.0275
5	3.64	.0389
6	3.60	.0416
7	3.64	.0083
8	3.68	.0317
9	3.66	.0366
10	3.63	.0408
11	3.66	.0411
12	3.65	.0338
13	3.65	.0296
14	3.65	.0372
15	3.65	.0447
16	3.67	.0333

A comparison of the vector diagram for February 24, 1931, with that of February 3, 1931, shows the large influence in time interval between runs. The vectors for February 24, 1931, have a mean velocity of .012 knots for a carriage speed of 4.90 knots and a 5 minute schedule against a mean of .028 knots on February 3, 1931, for a carriage speed of 3.65 knots and a 4 minute schedule.

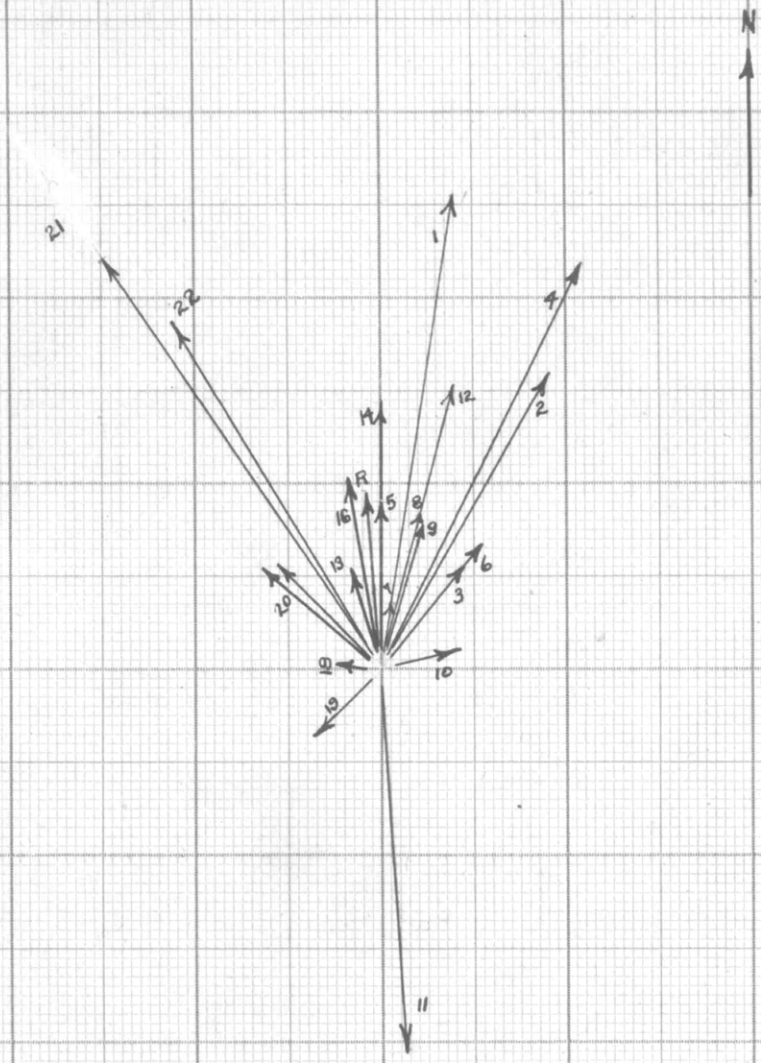
WATER CURRENTS IN MODEL BASIN
 FEB. 9, 1931 STATION 300 MODEL 3010 PROP 1020
 PICTURES TAKEN AS CARRIAGE APPROACHED

NO OF PICTURE	MINUTES SINCE LAST RUN	SPEED OF CARRIAGE PREVIOUS RUN KNOTS	WATER VELOCITY KNOTS
1	15	3.99	.0258
2	7	1.739	.018
3	7	1.849	.007
4	10	2.112	.024
5	7	2.315	.009
6	7	2.453	.010
7	8	2.565	.004
8	8	2.732	.008
9	9	2.97	.008
10	6	3.223	.001
11	7	3.237	.020
12	7	3.38	.015
13	8	3.547	.005
14	6	3.54	.014
15	8	3.68	.017
16	8	3.67	.010
17	4	1.65	.006
18	3	2.22	.003
19	3.9	2.49	.004
20	4	2.98	.006
21	2	3.40	.018
22	3	3.58	.008
R			.0096

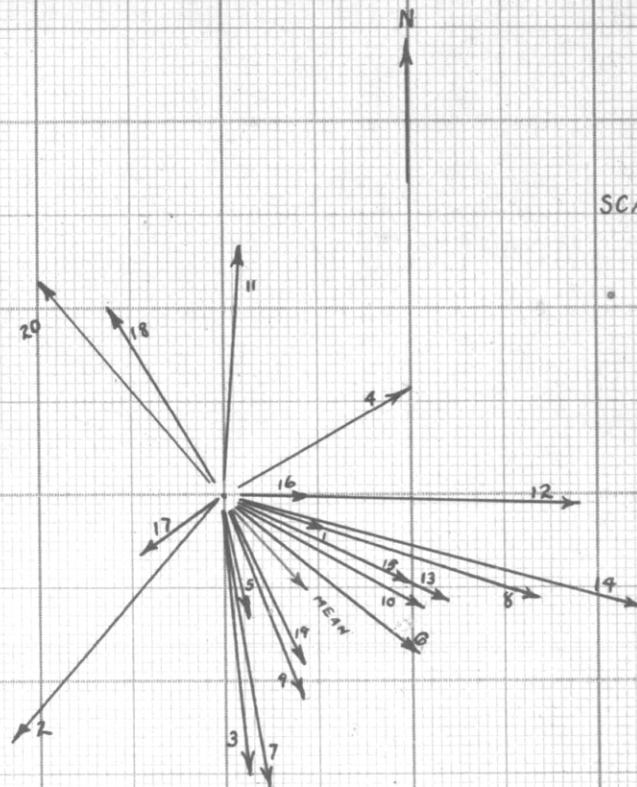
WATER VELOCITY IN MODEL BASIN
 MODEL 1080 PROPELLERS 1142-1143 FEB. 13, 1931

SCALE: 1 INCH = .01 KNOT

NO OF PICTURE	MINUTES SINCE PREVIOUS RUN	SPEED OF CARRIAGE PREVIOUS RUN KNOTS	VELOCITY OF WATER KNOTS	DIRECTION
1	7		.005	S70°E
2	9	4.23	.018	S41°W
3	5	4.41	.015	S5°E
4	5	4.58	.012	NG60°E
5	8	4.78	.007	S12°E
6	6	5.26	.013	S51°E
7	7	4.83	.018	S9°E
8	12	5.03	.018	S72°E
9	7	5.40	.012	S22°E
10	9	5.54	.013	S61°E
11	9	5.53	.013	N3°E
12	6	5.80	.019	S89°E
13	14	5.95	.013	S65°E
14	7	6.21	.023	S75°E
15	20	6.43	.011	S63°E
16	6	1.50	.004	S87°E
17	7	1.74	.005	S54°W
18	5	2.34	.012	N31°W
19	3	2.89	.010	S25°E
20	5	3.82	.015	N41°W
MEAN	7.8	4.32	.006	S41°E

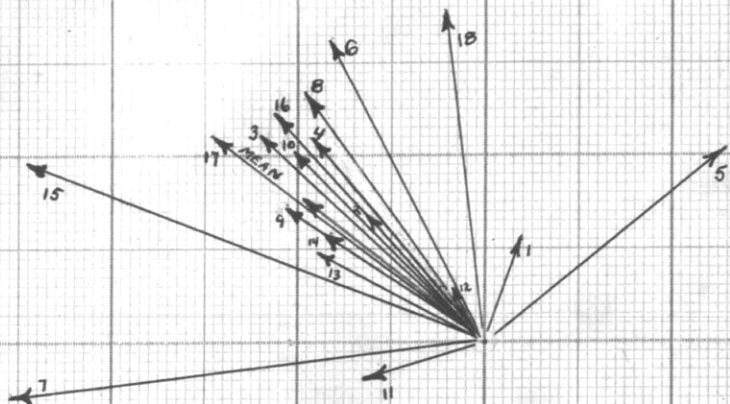
WATER CURRENTS IN MODEL BASIN

MODEL 2961 FEB 24, 1931 SCALE 1 INCH = .01 KNOTS

CARRIAGE RUNNING 4.30 KNOTS ON A 5 MINUTE SCHEDULE

№ OF PICTURE	VELOCITY OF WATER KTS	DIRECTION
1	.006	N19E
2	.009	N42W
3	.026	N47W
4	.014	N40W
5	.010	N51E
6	.018	N26W
7	.026	S83W
8	.016	N35W
9	.013	N55W
10	.014	N44W
11	.006	S73W
12	.003	N28W
13	.010	N62W
14	.010	N54W
15	.026	N69W
16	.017	N42W
17	.018	N53W
18	.017	N6W
MEAN	.012	N38W
