AN INVESTIGATION OF A FLOW-EXCITED VIBRATION OF THE  
USS FORREST SHERMAN (DD 931)

HYDROMECHANICS LABORATORY  
RESEARCH AND DEVELOPMENT REPORT

August 1958

Report 1188

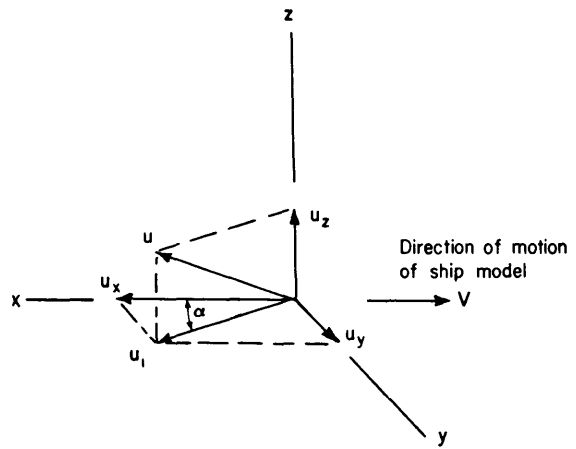
Figure 4 - Velocity Components and Directional Angle

A wake survey was conducted behind a powered model of the DD 931 class hull, to determine the effective velocity field at the rudders. The velocity components and directional angle are shown in Figure 4. The  $x$ -axis is taken in the direction opposite to the model velocity  $V$ , the  $y$ -axis athwartship (inboard), and the  $z$ -axis

upward. The flow velocity  $u$  has the rectangular components  $u_x$ ,  $u_y$ , and  $u_z$ .  $\alpha$  is the angle between the  $x$ -axis and  $u_1$ , where  $u_1^2 = u_x^2 + u_y^2$  ( $\alpha$  is positive when  $u_y$  is positive). Values of the speed ratio  $u_x/V$  and  $\alpha$  are shown in Figures 5 and 6. Since  $\cos \alpha$  is nearly one,  $u_x$  is approximately equal to  $u_1$ . Figure 5 shows the flow field at the leading edge of the port rudder, and Figure 6 shows the flow field at the port rudder stock. It appears that, with the model rudders toed-in 3 degrees, an effective angle of attack of about 7 degrees would exist over most of the rudder. The low pressure face would be outboard. The local flow velocity at the rudders is as much as 25 percent greater than the model speed (7 knots). Although these data might not be truly representative of the full-scale conditions at all speeds, they demonstrate that (1) the flow velocity at the rudder can considerably exceed the ship's velocity, and (2) the direction of flow at the rudders is not parallel to the ship's centerline, and the effective angle of attack varies appreciably over the entire rudder. Since the model test was conducted with Froude scaling, the test data approximate full-scale conditions. However, full-scale local boundary-layer and separation effects were not exactly duplicated by the test conditions.

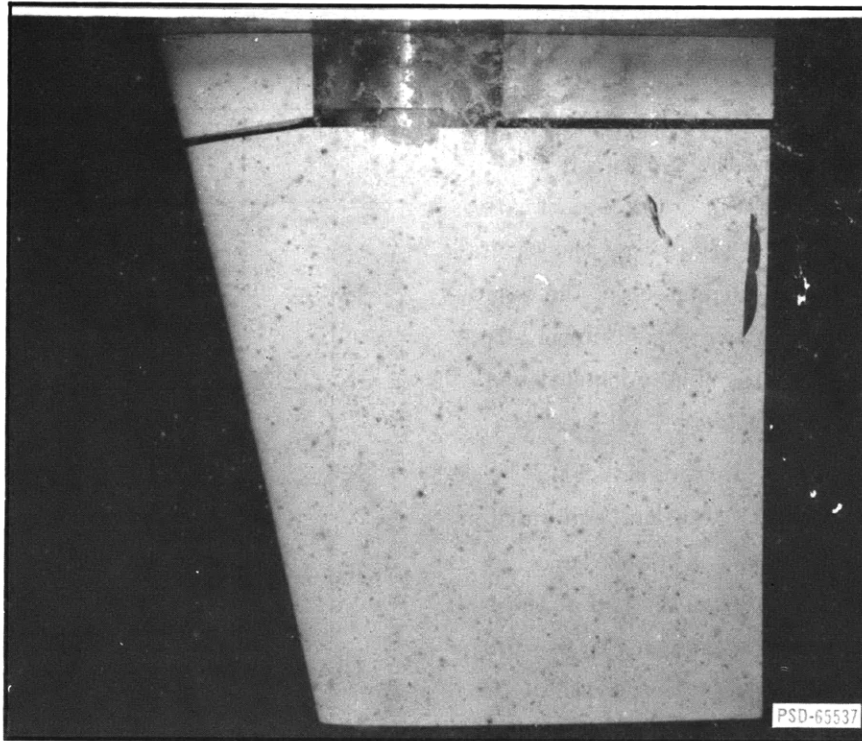
Figure 10 – Cavitation on Model Rudders at 0 Degree, 34 Knots

Cavitation tests on a model of the DD 931 type rudder including the fixed stock fairing were conducted in the TMB 24-inch variable-pressure water tunnel. Figures 10-14 show the cavitation patterns for various rudder angles. In each instance it can be seen that the stock and its fairing cavitated before any other part of the rudder system. Figure 10 shows that cavitation at zero attack angle occurred first at a point where the section profile was

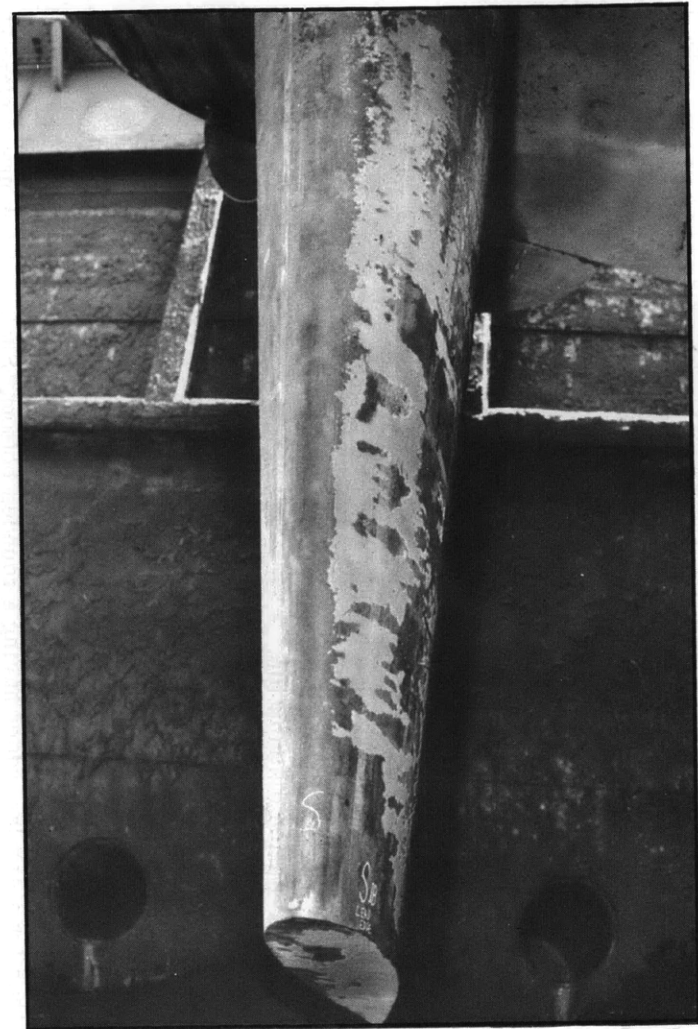
Figure 17 – Leading Edge of Starboard Rudder

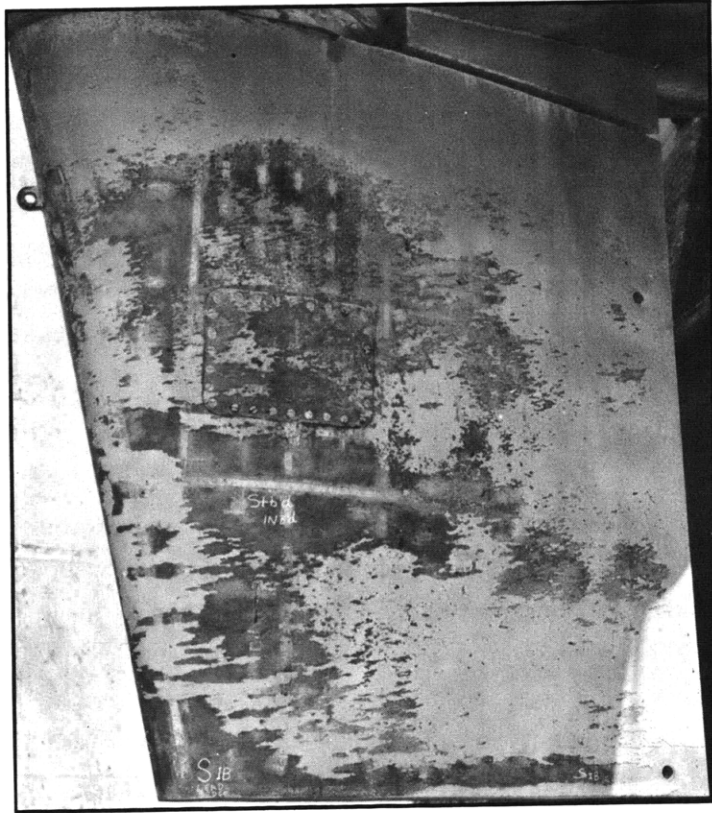
During turns at large rudder angles it is likely that cavitation will occur on the inner face and, with it, paint removal. At high attack angles, shedding of cavitating tip vortices should be expected to occur at the bottom of the rudder. The strength of these vortices is greater for a sharply truncated edge of the DD 931 rudder type than for a similar rudder having a rounded bottom. Such vortices are evidenced by the photograph of the model in Figure 14. The paint-removal pattern of both inboard faces of the DD 931 rudders is evidence of the probable existence of these cavitating tip vortices. As a matter of observation, the entire cavitation pattern on the model (Figure 14) resembles the paint removal pattern of the inboard face of the DD 931 starboard rudder.

Figure 18 – Inboard Side of Starboard Rudder

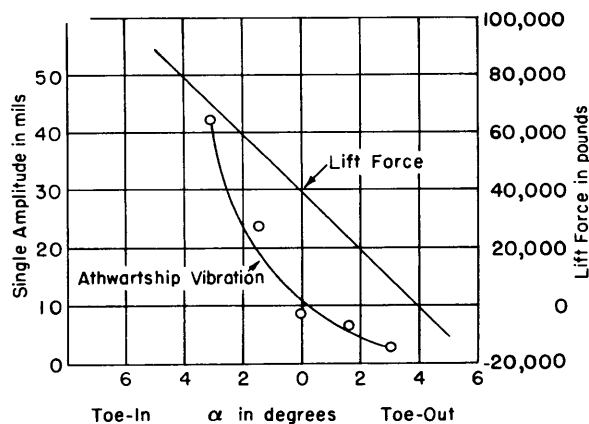
1. At 4 degrees toe-out the lift force is zero, and for small effective attack angles near this setting, rudder cavitation would not be expected in the (normal) operating speed range. This is consistent with the vibration amplitude curve also shown in Figure 19. The preset toe-in angle of 3 degrees represented an effective attack angle of 7 degrees, which constitutes a serious cavitation problem. The model cavitation index at 7 degrees is  $\sigma = 1.0$ . For a depth of 3 feet, cavitation at a local velocity of 28 knots would be expected. It has been shown that a local velocity of 28 knots at the rudder could occur at a ship speed of 22 knots. Hence, cavitation could start at this speed, and at a ship speed of 28 knots could be sufficiently serious to cause buffeting.

Figure 19 – Vibration Amplitude and Lift Force versus Rudder Toe Angle at Maximum Ship Speed

2. From the plotted lift curve, it is obvious that the lift developed on one rudder is quite large, being of the order of 70,000 lb. Periodic change of the lift due to cavitation fluctuations could provide the athwartship driving forces necessary to cause the vibration.

If one accepts a toe-out angle of 4 degrees as the effective zero angle for the rudder, based on Figures 5 and 6, then two important conclusions can be drawn from Figure 19 (reproduced from Figure 16 of Reference 2):
