EXPERIMENTAL DETERMINATION OF PRESSURE AND STRAIN  
ON THE BOW SONAR DOME OF USS BARRY (DD 933)

STRUCTURAL MECHANICS LABORATORY  
RESEARCH AND DEVELOPMENT REPORT

July 1960

Report 1395

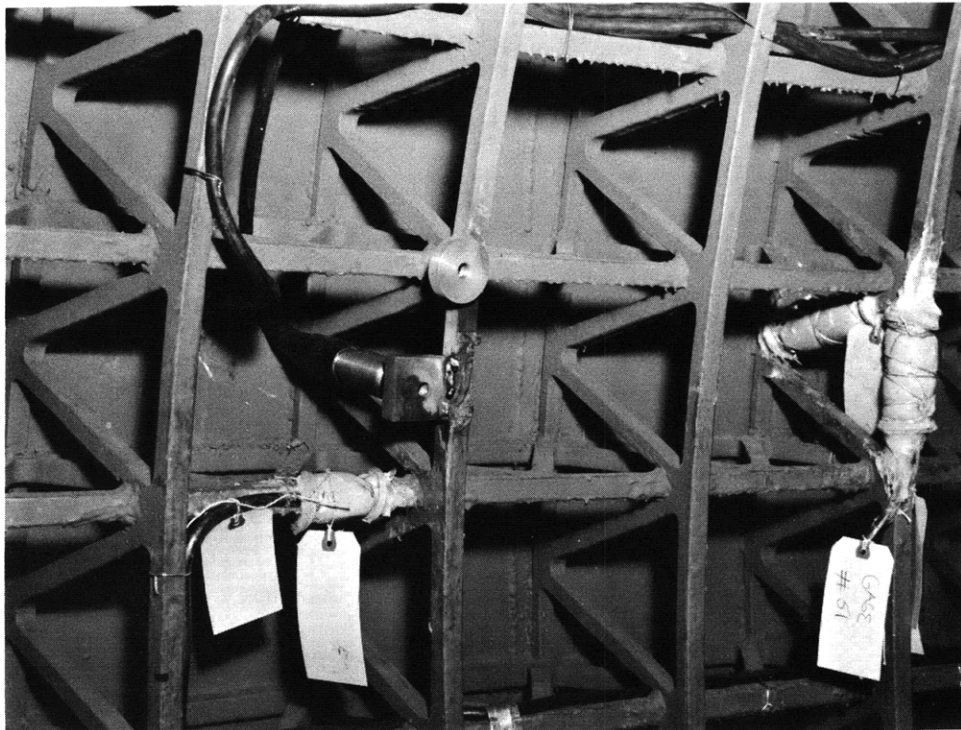
Figure 3 – Closeup of Trusswork in Dome

During installation of the removable section some of the instrumentation was damaged. Then additional damage was caused when the dome was flooded because of the very limited amount of area for waterproofing at each strain-gage location on the narrow (¾-in.) trusswork. The damage was not discovered until after the ship was undocked; thus the repairs had to be made while the ship was in the water. A complete repair of strain gages was impossible because of excessive condensation and leaks in the dome. No repair of pressure gages was possible since they were exposed to the sea and removal would have flooded the dome. Hence it was possible to repair only about half of the instrumentation. The gages that were repaired were waterproofed with Epibond.\*
