HYDROSTATIC PRESSURE TESTS OF UNSTIFFENED AND  
RING-STIFFENED CYLINDRICAL SHELLS FABRICATED  
OF GLASS-FILAMENT REINFORCED PLASTICS

STRUCTURAL MECHANICS LABORATORY  
RESEARCH AND DEVELOPMENT REPORT

September 1963

Report 1745

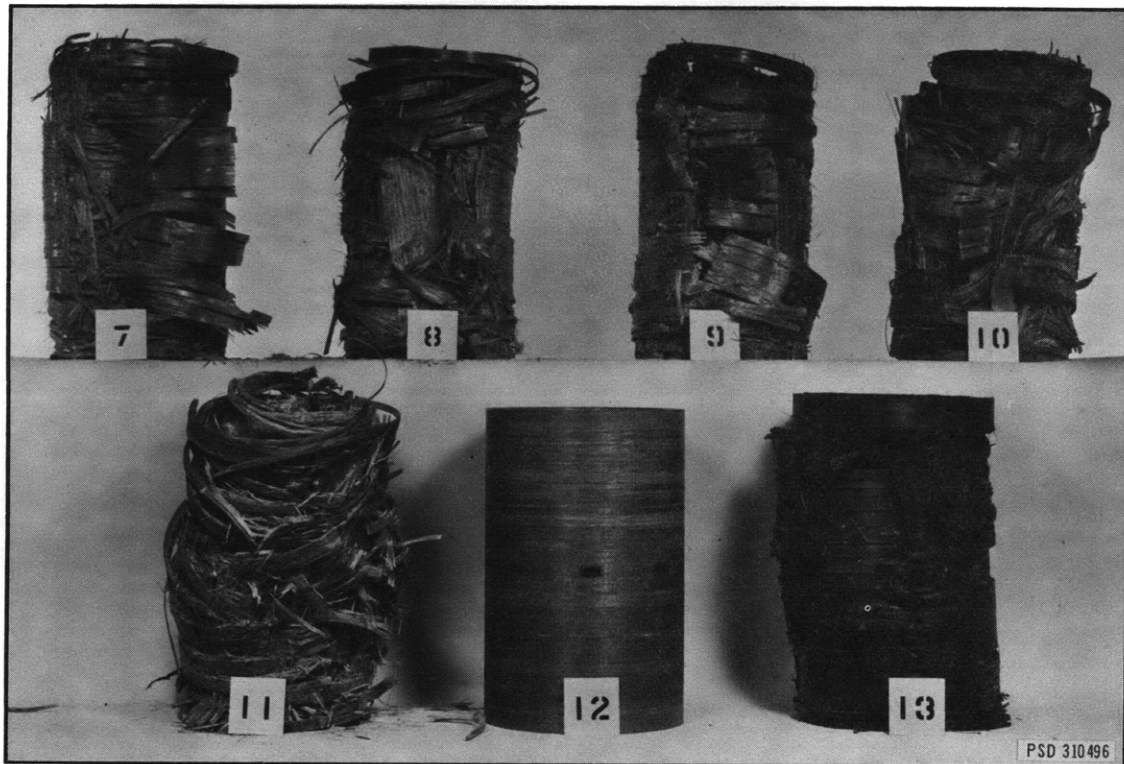
Figure 4 - Cylinders B-7 to B-13 after Failure

It was mentioned previously in this report that the inside surfaces of Cylinders B-9, B-10, B-11, B-12, and B-13 were crazed during fabrication. A comparison of the collapse strengths of B-8 and B-9, two cylinders of nearly equal thickness, affords an opportunity to assess the effects of this type of imperfection. Cylinder B-8, one without any visible defects, failed at a pressure of 12,950 psi; B-9, the crazed cylinder, had a collapse pressure of 8200 psi. Thus, the overall strength of Cylinder B-9 appeared to be seriously reduced by crazing of the laminate. It is interesting also to note that prior to failure, stresses over 100,000 psi were developed in a few of the crazed cylinders. In fact, the highest stress level obtained for any of the cylinders tested was that achieved by a crazed cylinder (B-13).

Photographs of all of the cylinders after failure are shown in Figures 2 through 8. Cylinders B-6 to B-13, G-4, H-7, H-8, Z-5, Z-6, and HT-1 to HT-7 were tested to collapse in large volume, high pressure tanks; the cylinders were not filled with oil and vented to the atmosphere. Thus, the energy released at failure by the pressurizing medium was unrestrained and extensive damage occurred in these cylinders, as can be seen in the photographs.

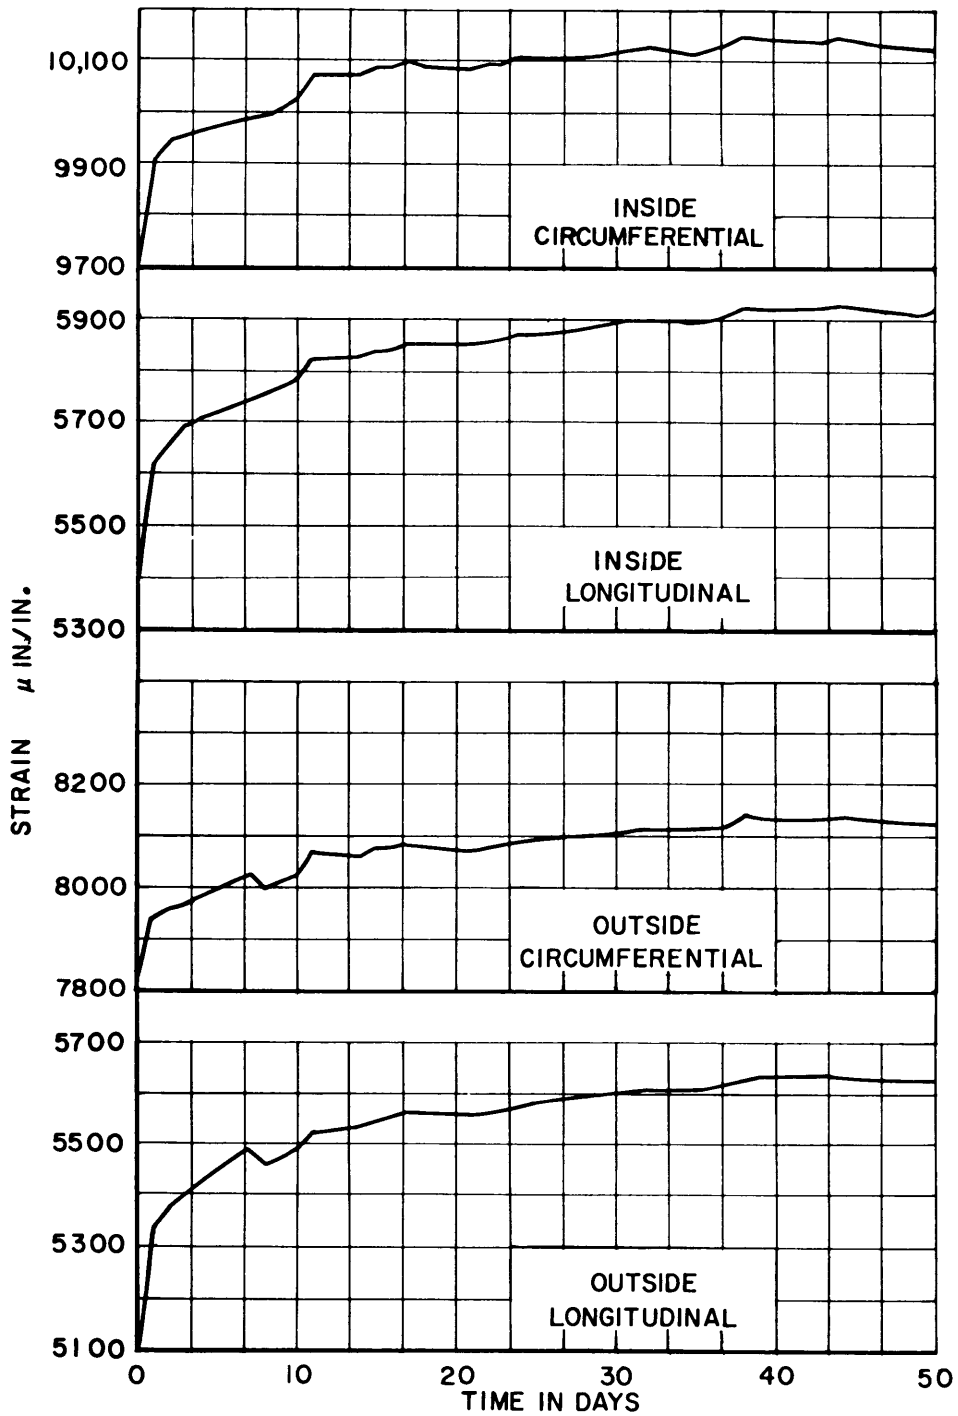
Figure 9 - Strain History of Cylinder Z-5 at Stress Level of 60,000 psi

The strain-time histories shown in Figure 9 represent the average measurements of gages located at midlength of Cylinder Z-5. An examination of these curves reveals that creep strain on the order of 200 to 400  $\mu\text{in./in.}$  occurred mostly in the first 10 days of constant load and that insignificant changes in strains occurred thereafter.

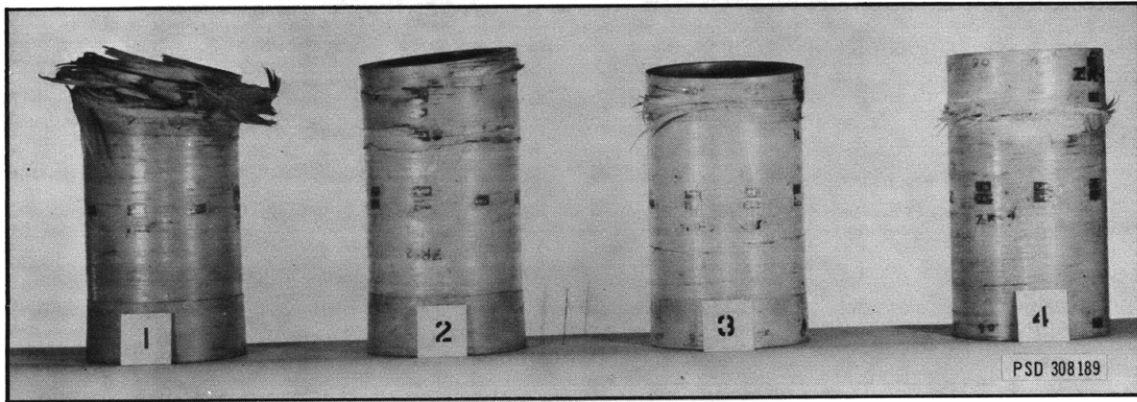
Figure 15a - Exterior View

Figure 15b - Interior View

Figure 15 - ZR-Models after Failure

of Models ZR-1 and ZR-2 were tested by Zenith Plastics with resulting collapse pressures of 7300 and 6500 psi, respectively. It appears that there was a premature failure for Model ZR-1. When all of these facts are taken into consideration, a short-term collapse pressure on the order of 7500 psi at a weight-displacement ratio of 40 percent appears to be representative of GRP ring-stiffened cylinders fabricated under high quality control. This reflects the considerable weight saving in hull structures that can be realized with glass-reinforced plastics.
