NAVY DEPARTMENT
DAVID TAYLOR MODEL BASIN
WASHINGTON, D. C.

WELDING TEST 206
PHYSICAL CHARACTERISTICS OF WELDED LONGITUDINAL SEAMS

March 1943

Report R-129

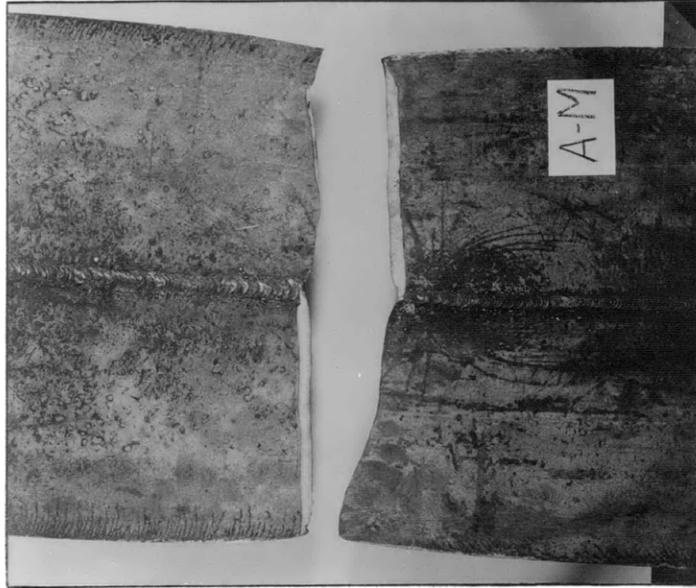
Figure 15 - Medium Steel Specimen A-M after Test
Note the Lüders' lines at the edges of the plate and at the longitudinal seam to the right of the fracture.

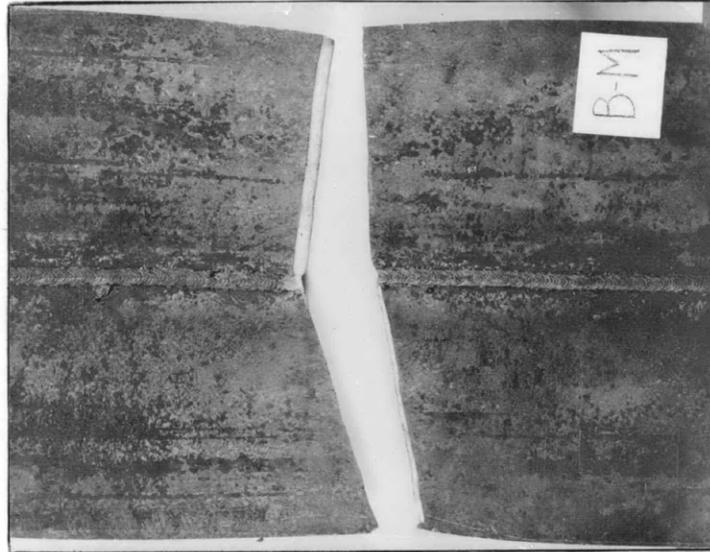
Figure 17 - Medium Steel Specimen B-M after Test,
showing Rupture Section

The transverse welded butt was about a foot from the rupture, just beyond
the limits of the photograph.

Figures 17 and 19 show similar ruptures in Specimens B-M and C-M at some distance from the transverse weld. The fact that the fracture of specimens with a transverse weld occurs at a distance from the transverse weld has been observed in previous tests (2).

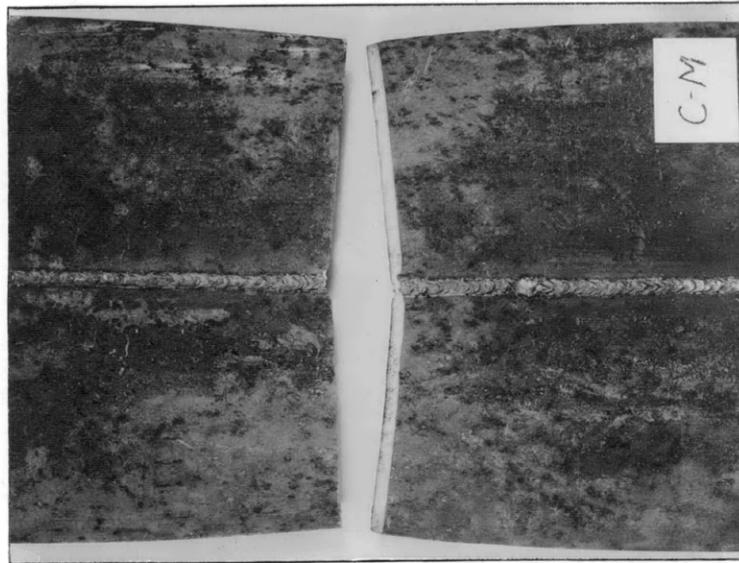
Figure 19 - Medium Steel Specimen C-M after Test
The rupture occurred about 3 feet from the transverse welded butt.

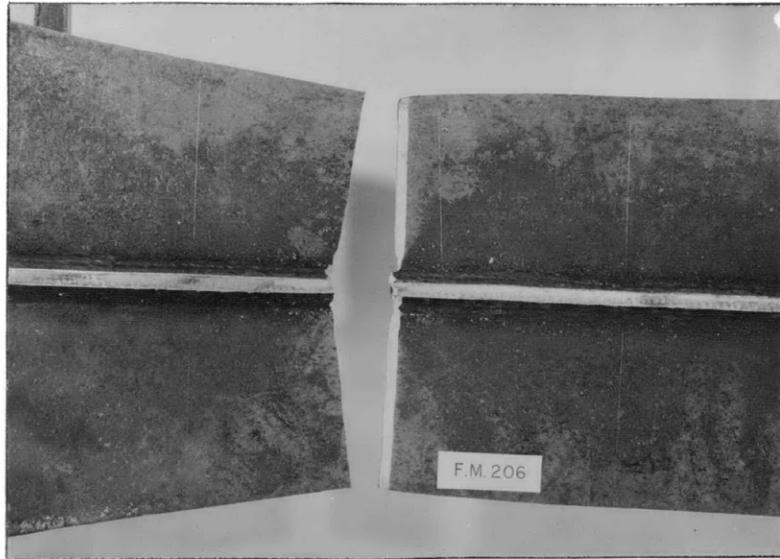
Figure 23 - Medium Steel Specimen F-M after Test
The greater separation of the rupture surfaces at the webs illustrates
the lower ductility of the section at the welds.

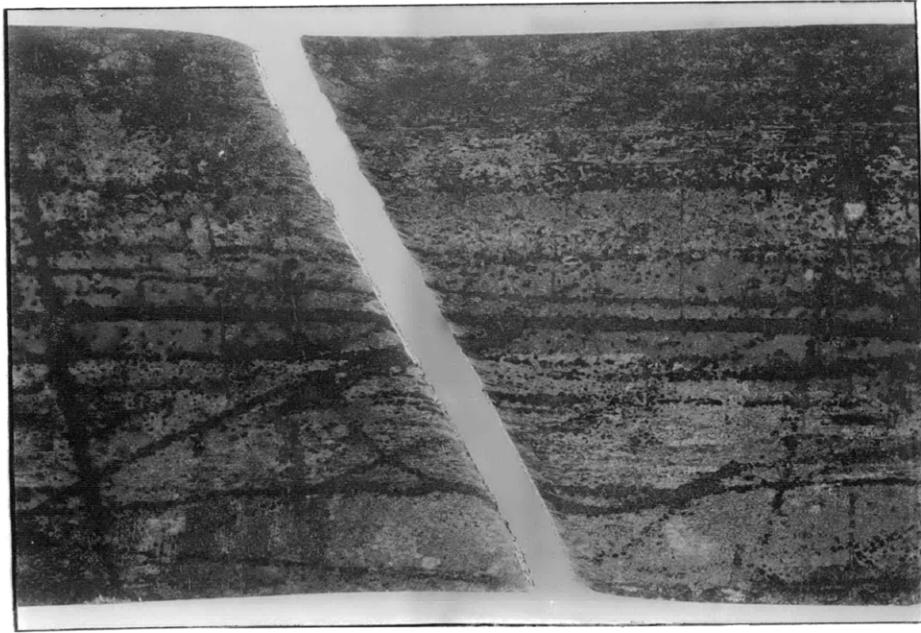
Figure 31 - High Tensile Steel Control Specimen G-H after Test

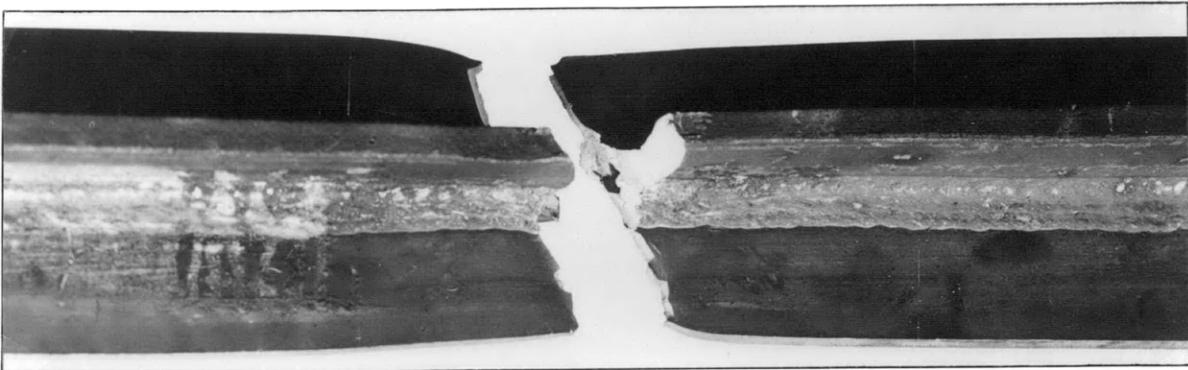
Figure 36 - Special Treatment Steel Specimen F-S after Test
The rupture occurred about 3 feet from the transverse web.

The differences between medium steel and high tensile steel are roughly paralleled by those between high tensile steel and special treatment steel. In the case of special treatment steel the speed of rupture was too fast to catch with the framing speed, 16 per second, in the camera used. But so far as the still photographs can show them, all the irregularities noted in special treatment steel may be seen in Figures 32 to 37 of Appendix 1.
