THE DAVID W. TAYLOR MODEL BASIN

FATIGUE TESTS OF DIESEL ENGINE PISTON RODS
WITH AND WITHOUT SPRAYED METAL COATING

AUGUST 1942

REPORT 493

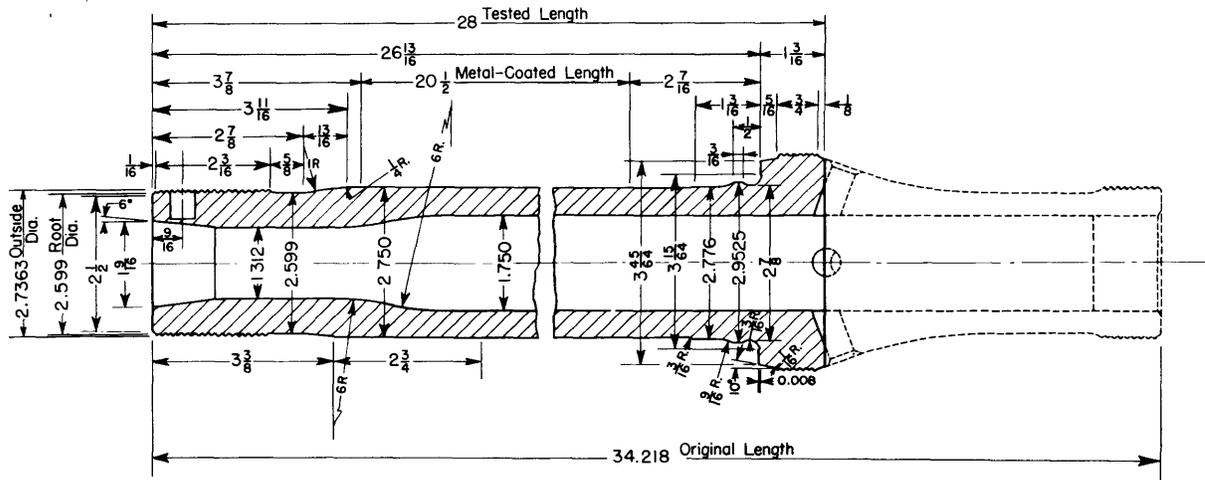
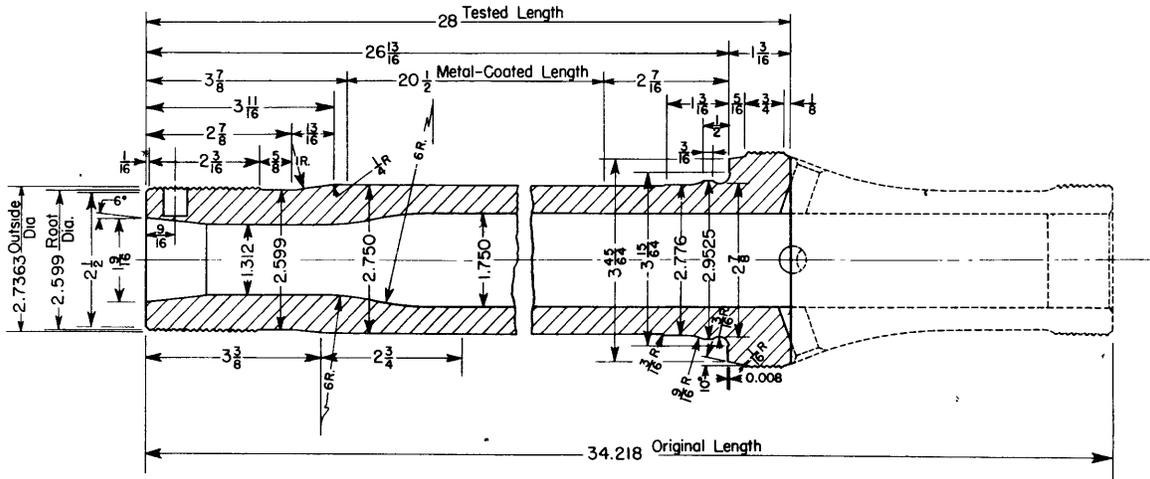
Figure 1 - Details of Specimen

The complete rod is outlined. The portion to the right, shown in broken lines, was removed before testing to facilitate gripping in the alternating load machine.

The details of the specimens used in the tests are shown in Figure 1. The rods which were submitted were completely finished, but since the part to be tested was that portion to the left of the large diameter, the section shown in broken lines at the right in Figure 1 was carefully removed and the end surface was ground normal to the axis of the rod.

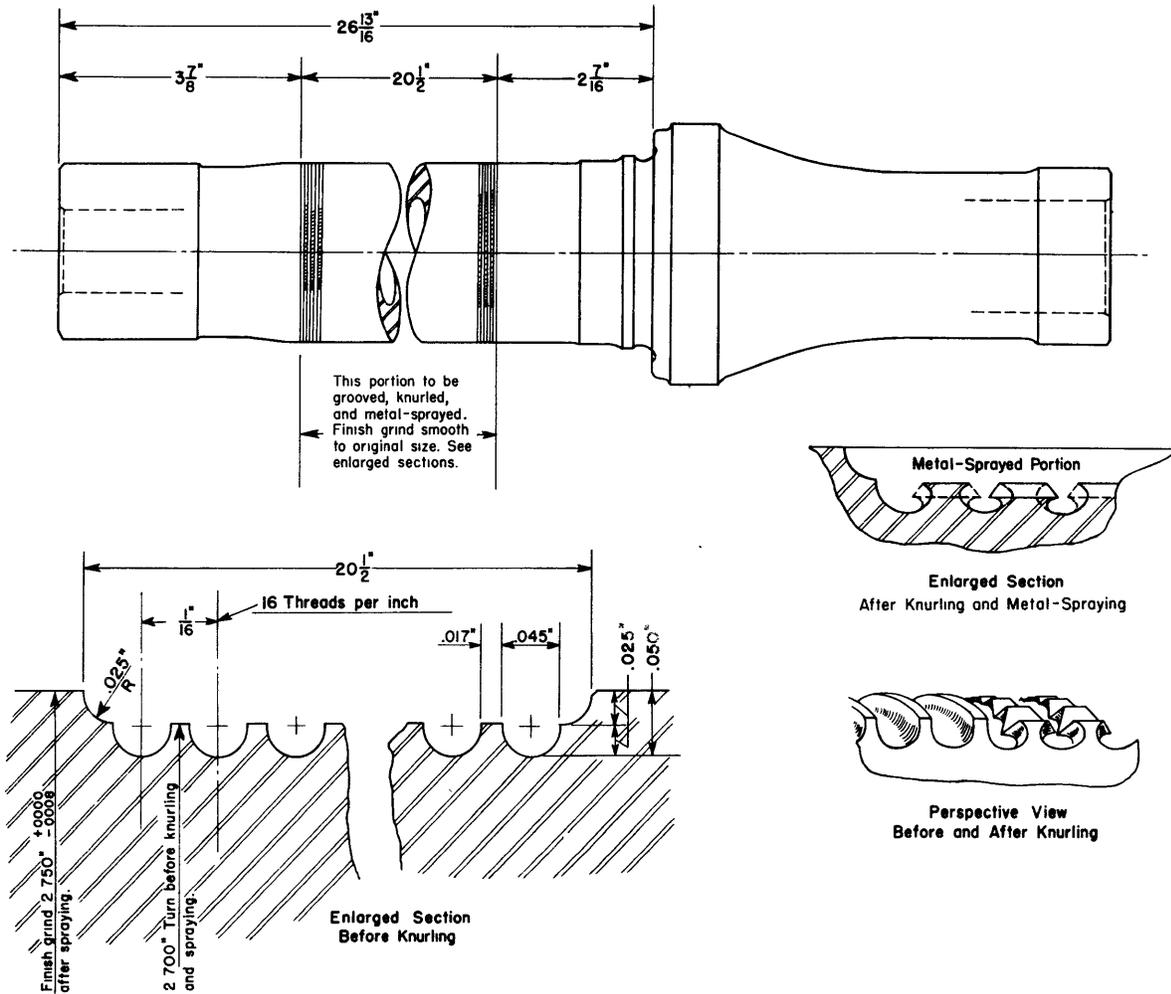
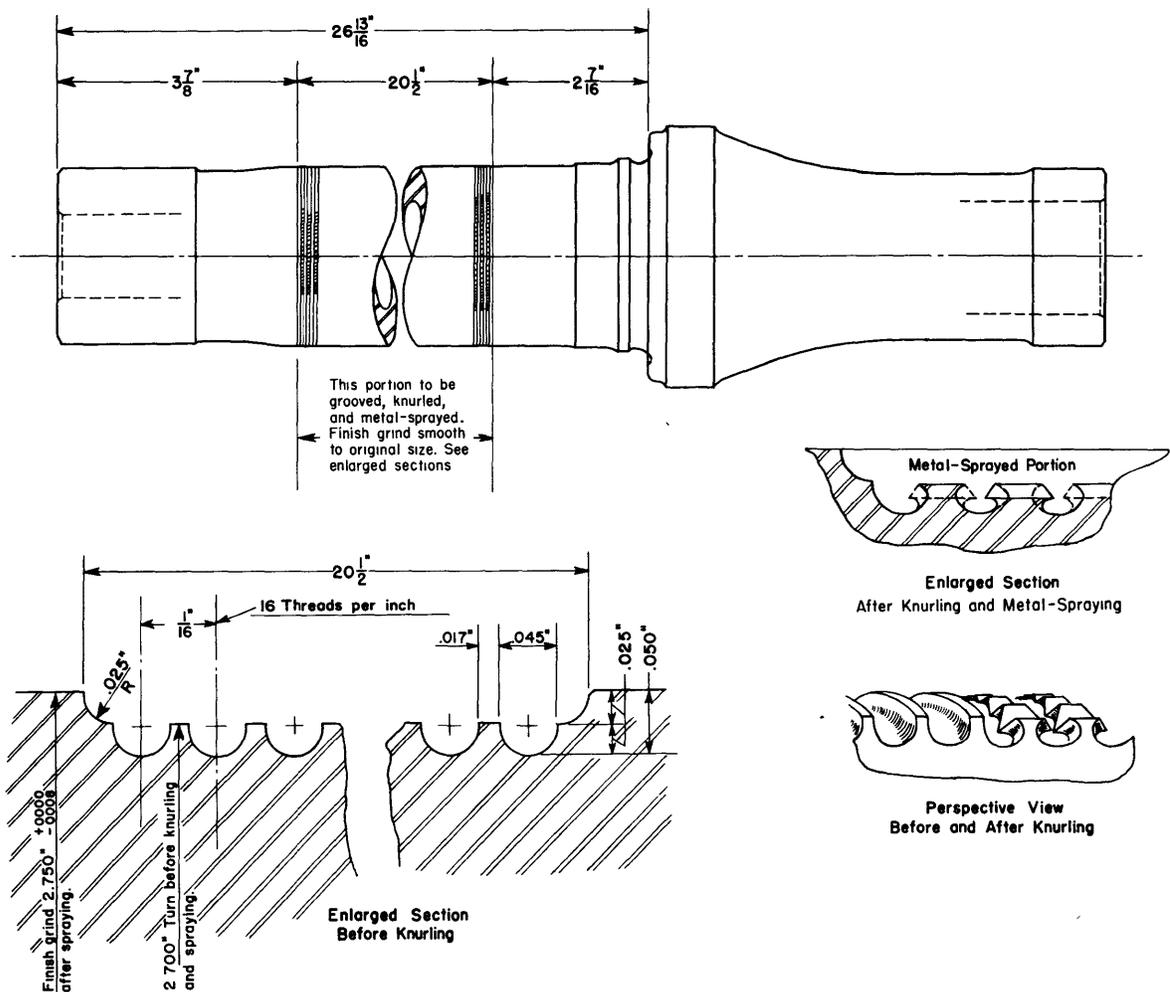
Figure 20 - Sketch showing Preparation and Details of Metal-Coated Rods

The section of the rod to be metal-coated was first turned to a diameter of 2.700 inches. It was then prepared for bonding the metal coat by cutting 16 threads to the inch with a round-nosed tool. The threads were then knurled to increase the bonding effect.

The metal-coated rods designated as Specimens NMC1, NMC2, and NMC3 were manufactured from the same material and in the same manner as Specimens N1, N2, and N3. After completion, however, the piston rods were turned to a diameter of 2.700 inches. To assure adequate bonding of the metal coat with the rod a 16-pitch thread was cut with a special round-nosed tool which produced a round-bottom groove as shown in the section of Figure 20. The threads were then knurled, after which the metal was sprayed on in one pass, building the diameter up to 1/16 inch over the desired finished diameter. The wire used for metal-spraying was 1/8 inch in diameter and contained 0.80 per cent carbon.

In the metal-spraying process it is of utmost importance that the correct spraying technique be used so that a fine-grained deposit is obtained without lamination. The long, uninterrupted surface of 20 1/2 inches must be sprayed in one continuous operation.

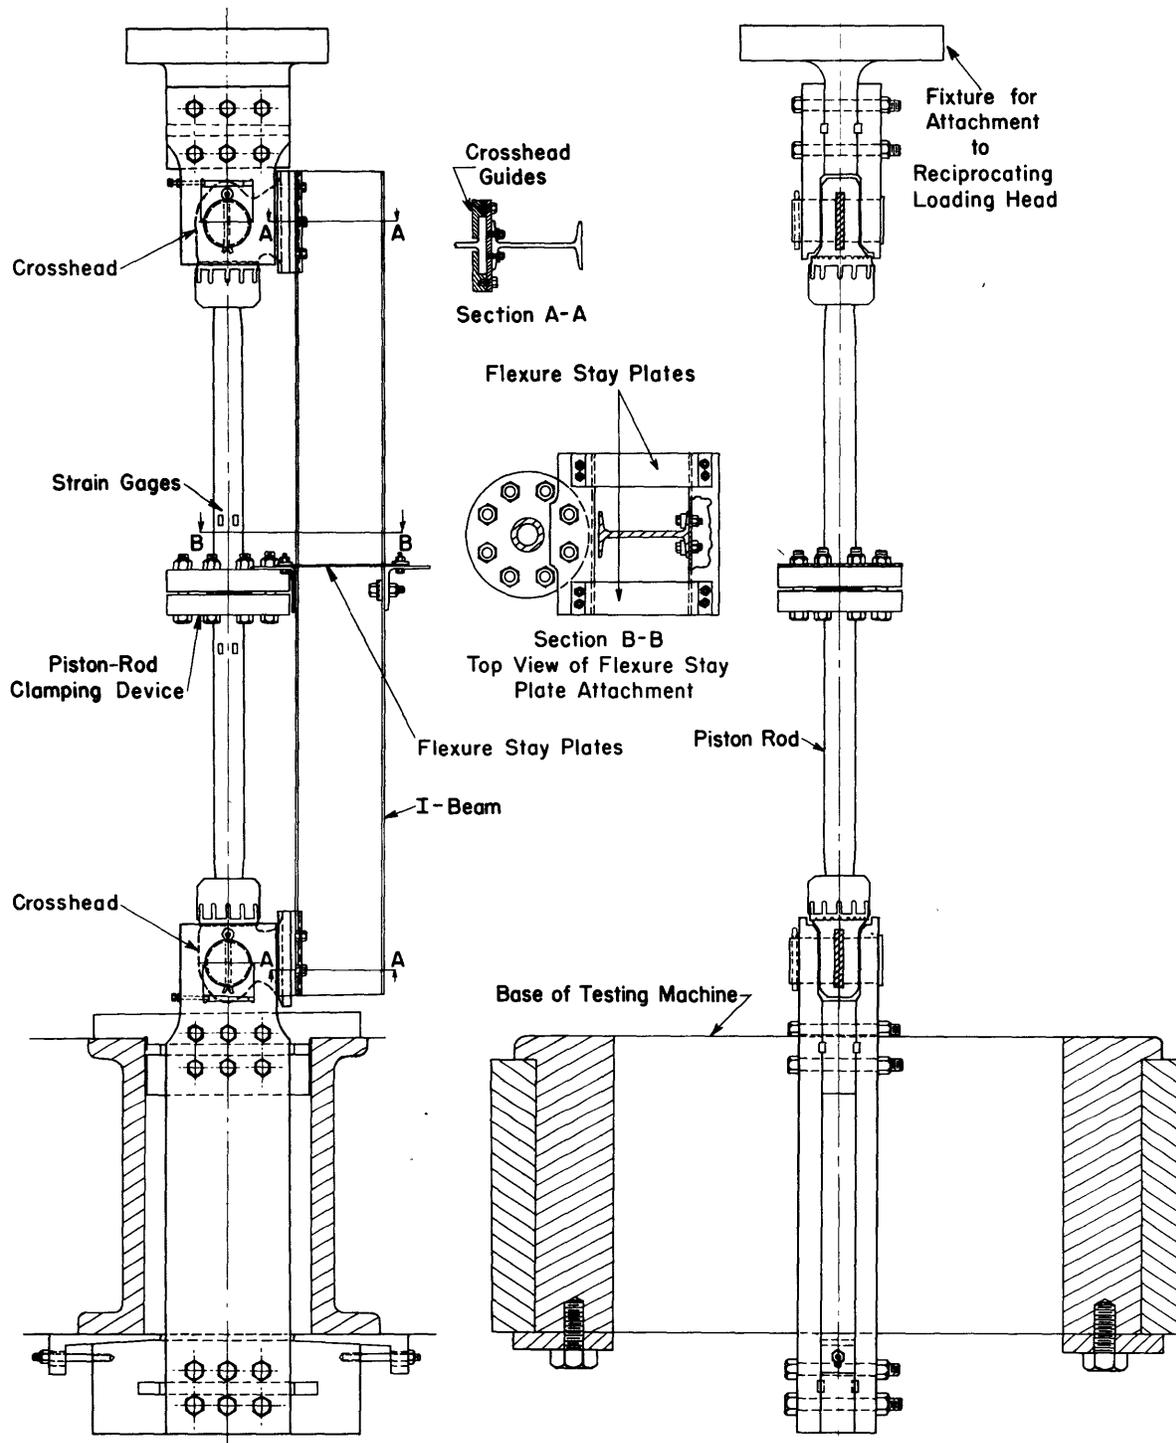
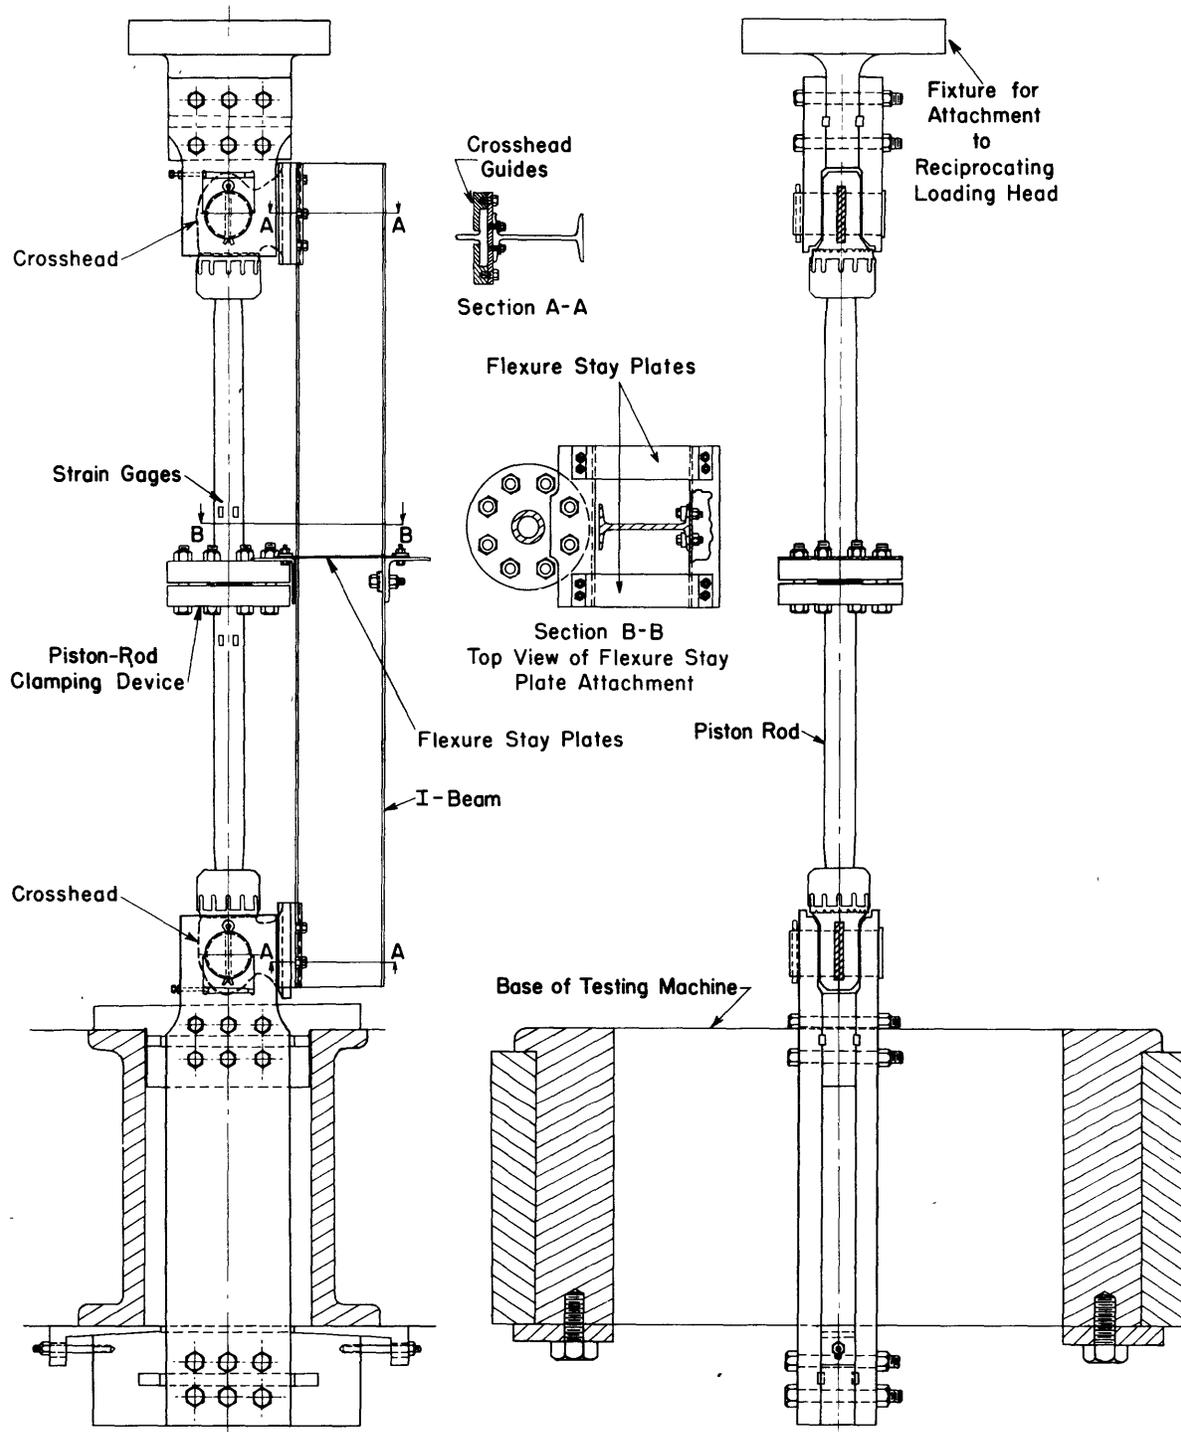
Figure 8 - Sketch of Rig for Testing Rods in Alternating-Load Testing Machine

Two rods were clamped together at the piston ends and were tested at the same time. Details of the clamping are shown in Figure 11 of the report. The crossheads were constrained to move in a straight line by having the slippers move in guides bolted to an 8-inch I-beam. The rods were attached to this beam at the center through flexure stay plates which provided support against column buckling.

The rods were tested in the 150,000-pound alternating-load testing machine at the David W. Taylor Model Basin.* It was necessary to design and build a special rig for these tests, as shown in Figures 8 and 9. The clear distance between the yokes was sufficient to test two specimens at one time.

Two rods were clamped together at the piston ends and were tested at the same time. Details of the clamping are shown in Figure 11. The crossheads were constrained to move in a straight line by having the slippers move in guides bolted to an 8-inch I-beam. The rods were attached to this beam at the center through flexure stay plates which provided support against column buckling.

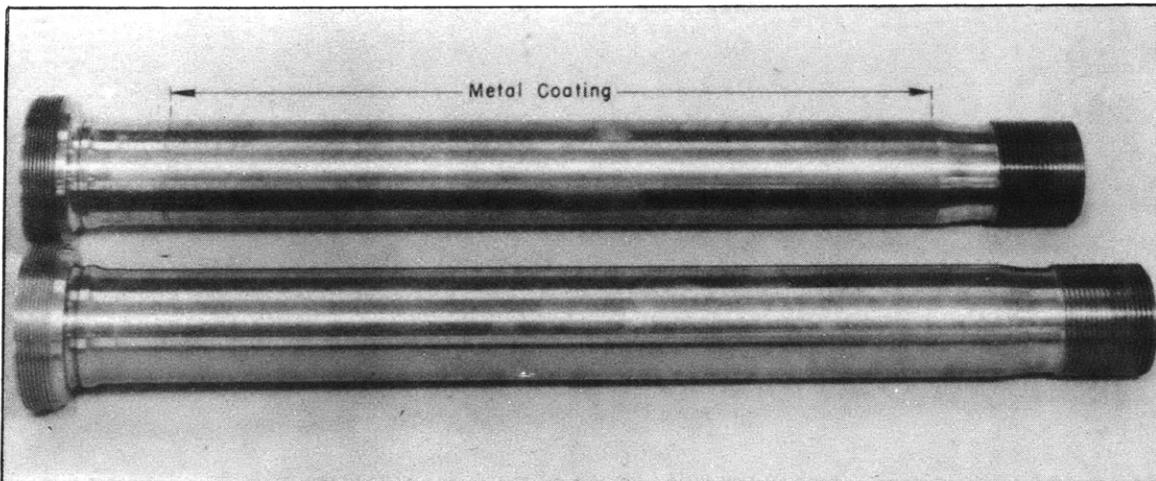
Figure 7 - Specimens as Altered for Testing

The specimen at the bottom is a new rod of the N series without metal coating. The one at the top is a new metal-coated rod of the NMC series. The metal coating is easily distinguishable by its darkened color.

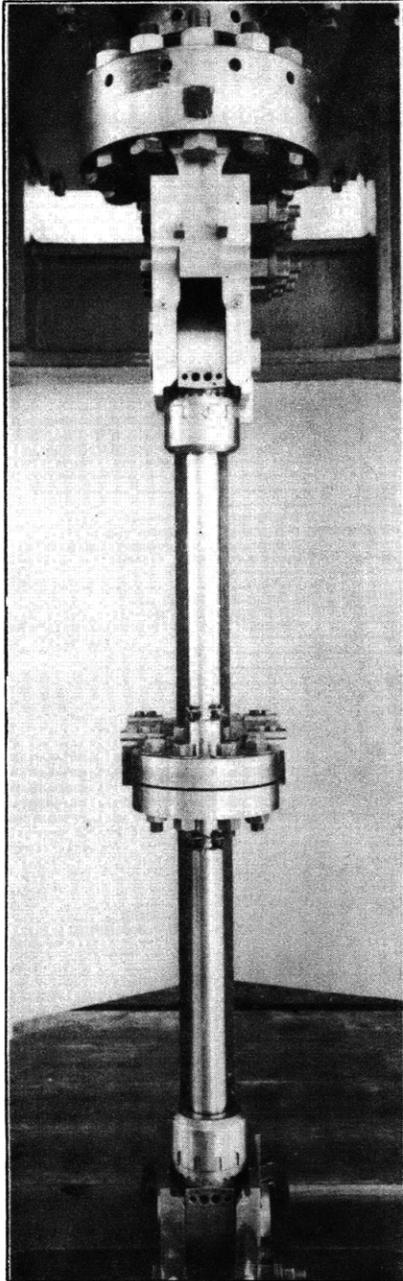
Figure 9 - Photograph showing Two Rods set up in Alternating-Load Testing Machine ready for Test

The I-beam support is behind the rods. Note the flexure stay plates on each side connecting the I-beam to the heavy disks at the center. The four small dark objects, two above and two below the heavy disks, are Tuckerman optical strain gages.

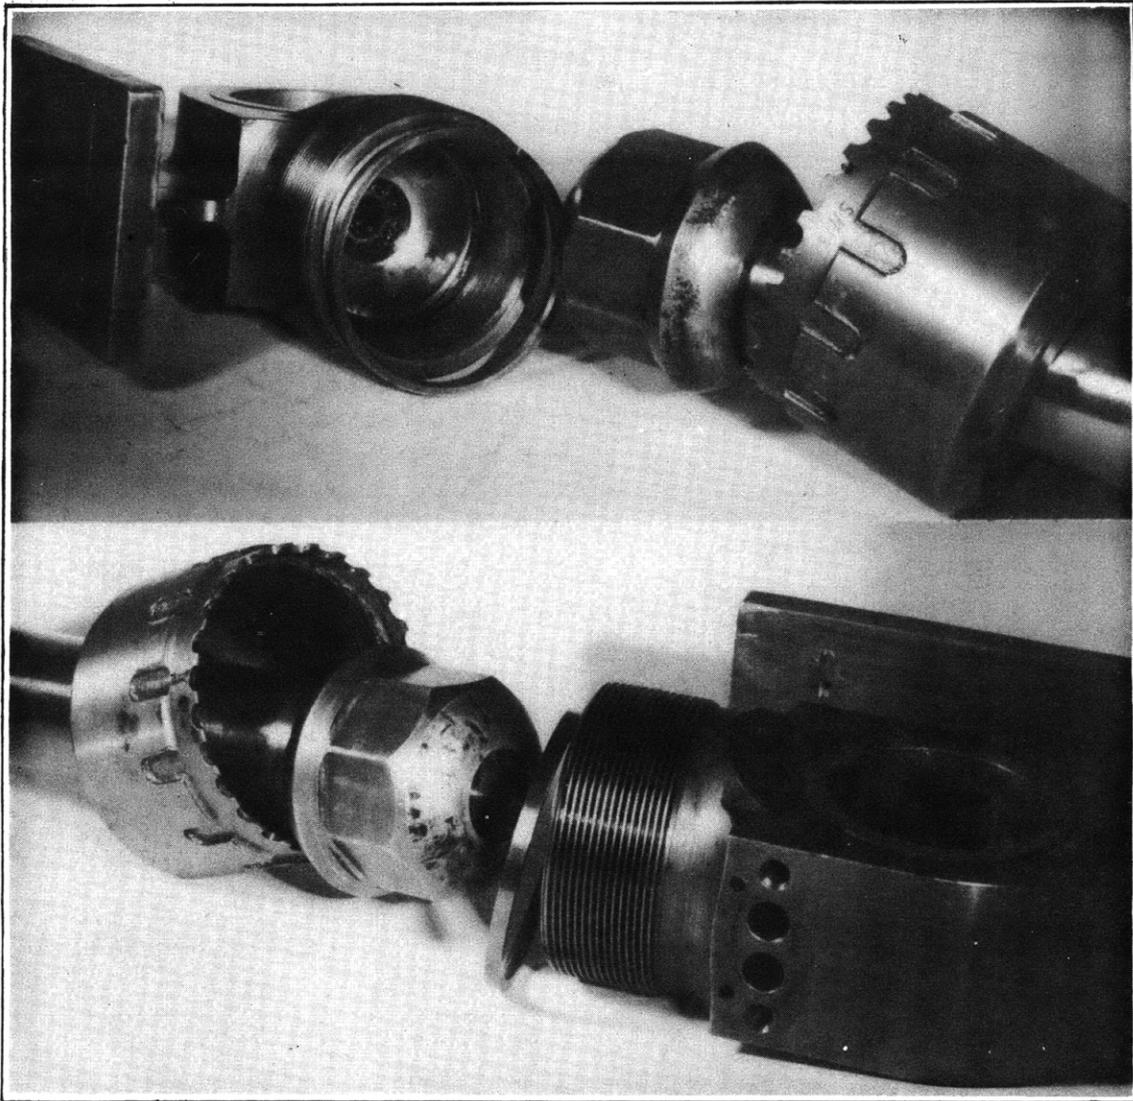
Figure 10 - Photographs of Disassembled Crosshead and Crosshead End of Rod showing Spherical Nut and Seat

The crosshead ends of the rods were held exactly as they would be in the engine, in order that working conditions might be duplicated as nearly as possible. Crossheads were procured from the manufacturer for this purpose. The crossheads were held in place by wrist pins through the yokes, and were free to turn slightly on the pins. The crossheads were designed by the engine builder so that moment due to rocking of the crosshead would not be transmitted into the rod, by building a spherical seat into the crosshead. A spherical brass nut was screwed onto the piston rod and was fitted into the seat. A large cover nut held the assembly together. The disassembled crosshead, nut, and rod are shown in Figure 10.

This arrangement permits rotation of the rod with reference to the crosshead without imposing a bending moment on the rod.

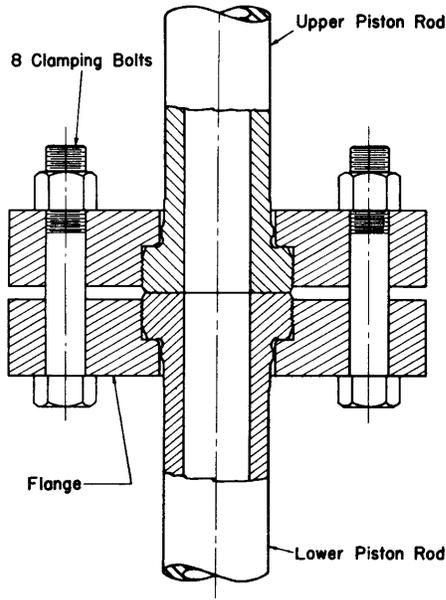
Figure 11 - Section showing the Piston Ends of the Rods clamped together during a Test

The Bureau of Ships directive (1) on this project stated that "If it is so desired the excess length at the right (piston) end may be cut off." Taking advantage of the available space between the loading heads of the testing machine, and of the Bureau authorization, the Model Basin cut off the rod inside the piston as shown in Figure 1, carefully squared and ground the ends, and clamped the piston ends of two rods together by the heavy disks shown in Figure 11.

To prevent the adjacent rod ends from separating and hammering during the test, it was necessary to apply an initial compressive load on the rod ends, by the disks and bolts, greater than the maximum tension load expected during any part of the test. This load was applied wholly on the flat end of the enlarged portion, and it resulted in an initial compressive stress in the metal under this surface greater than the stress would have been if the two rod ends had not been clamped together and the assembly had been put under tension.

The large ends of the rods were threaded into the counterbored recesses in the plates.

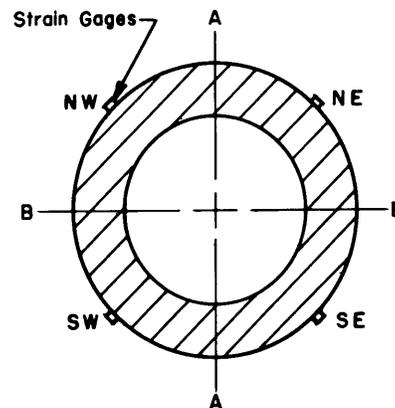
Figure 13 - Cross-Section of Rod with Tuckerman Strain Gage Stations and Principal Bending Axes

Axis A-A would be the neutral axis of any bending which might be introduced by the slight linear displacement due to rocking of the loading head of the testing machine about its pivot.

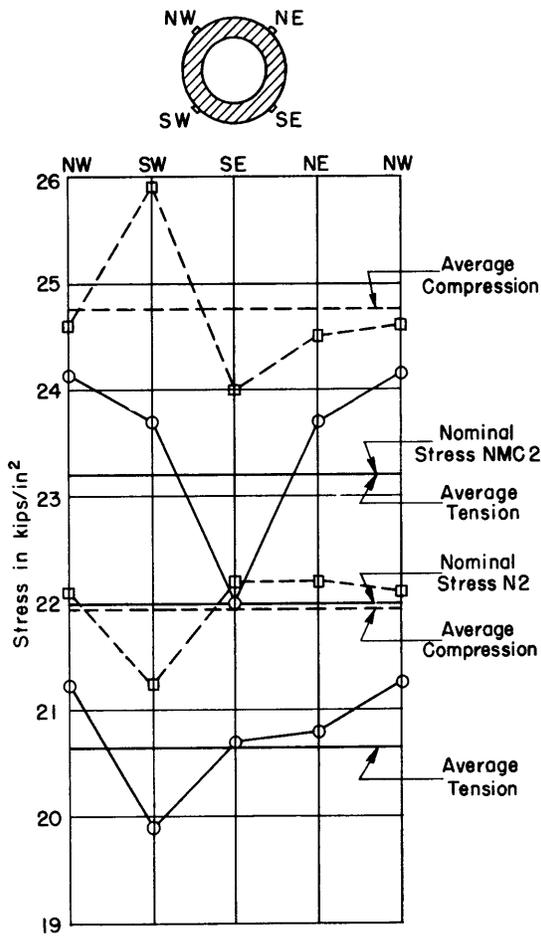
Figure 14 - Distribution of Stresses around the Circumference of Specimens N2 and NMC2

The stresses are derived from Tuckerman strain gage data. An elastic modulus of 30×10^6 pounds per square inch was assumed.

The results of the static measurements of distribution of stress about the circumference of the rods are given in Table 3; these results are shown graphically in Figure 14. The accuracy of the strain measurements taken on the metal-coated rods is open to question since the coating itself does not carry an appreciable stress. The variation is somewhat greater on the coated rod than on the uncoated one and is not in the same direction at corresponding points. This deviation is small in comparison with measurements made on other testing machines used for similar tests (3). The maximum deviation from the average, however, does not in any case exceed 5 per cent.

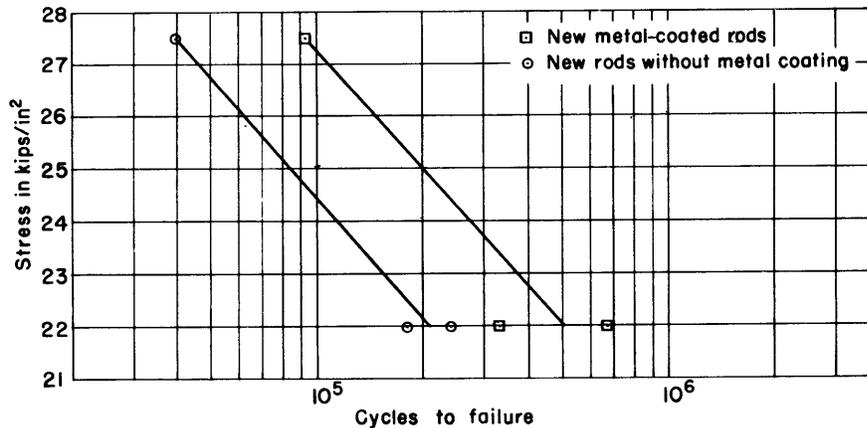
Figure 17 - Partial S-N Diagrams for N and NMC Specimens

The S-N* diagrams for the specimens of the N and NMC series are shown in Figure 17. It is apparent from these diagrams that the NMC specimens had a higher endurance limit than the N specimens over the range tested. The marked difference between the strengths of the N and NMC rods is surprising, since the rods were supposed to be identical except for the metal coating. All failures occurred in parts of the rods which could not possibly have been affected by the metal-coating process. Consequently, although the tests gave valuable information about the fatigue strength of the rods, they gave no conclusive evidence as to the effect of the metal coating.

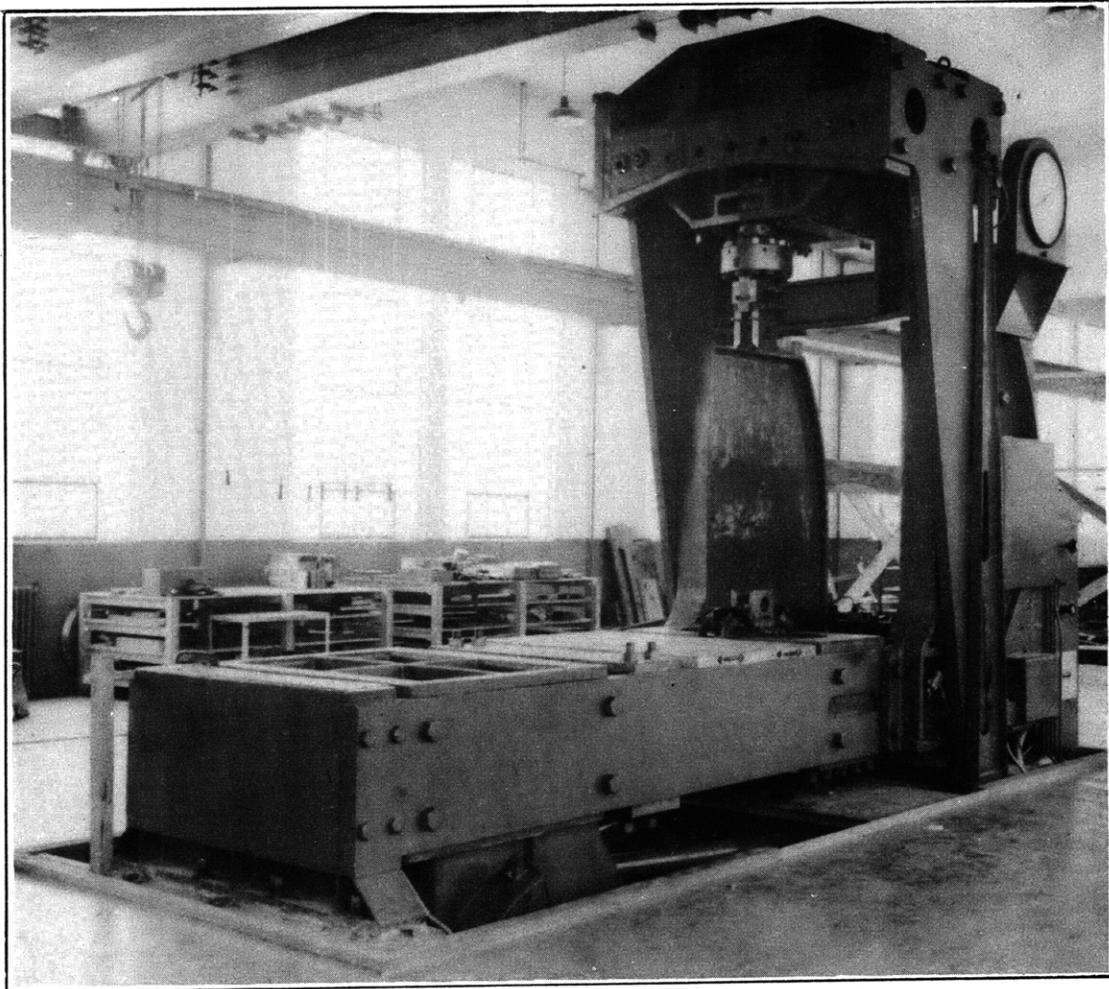
Figure 21 - Alternating-Load Testing Machine of 150,000 Pounds Capacity
at the David Taylor Model Basin

The tests were conducted in the alternating-load testing machine shown in Figure 21. This machine is, so far as known, the only one of its particular type in existence. It is capable of exerting a load of 150,000 pounds either upward or downward on beam-type or column-type specimens. Deflections of 1/2 inch in either direction can be applied at loads up to 50,000 pounds and of 1/8 inch for loads of 150,000 pounds. The machine can be operated at any speed from 10 cycles to 250 cycles per minute.

The loading head at the top with the upper testing fixture hanging from it moves up and down, while the lower testing fixture is attached to the frame of the machine and remains stationary.
