Memorandum 6M-3940

SUBJECT: RESULTS OF THE SYSTEM TEST (PHASE II) PERFORMED ON THE
AN/FSQ-7 (XD-1) DURING JULY, AUGUST, AND SEPTEMBER 1955

Date: 1 November 1955

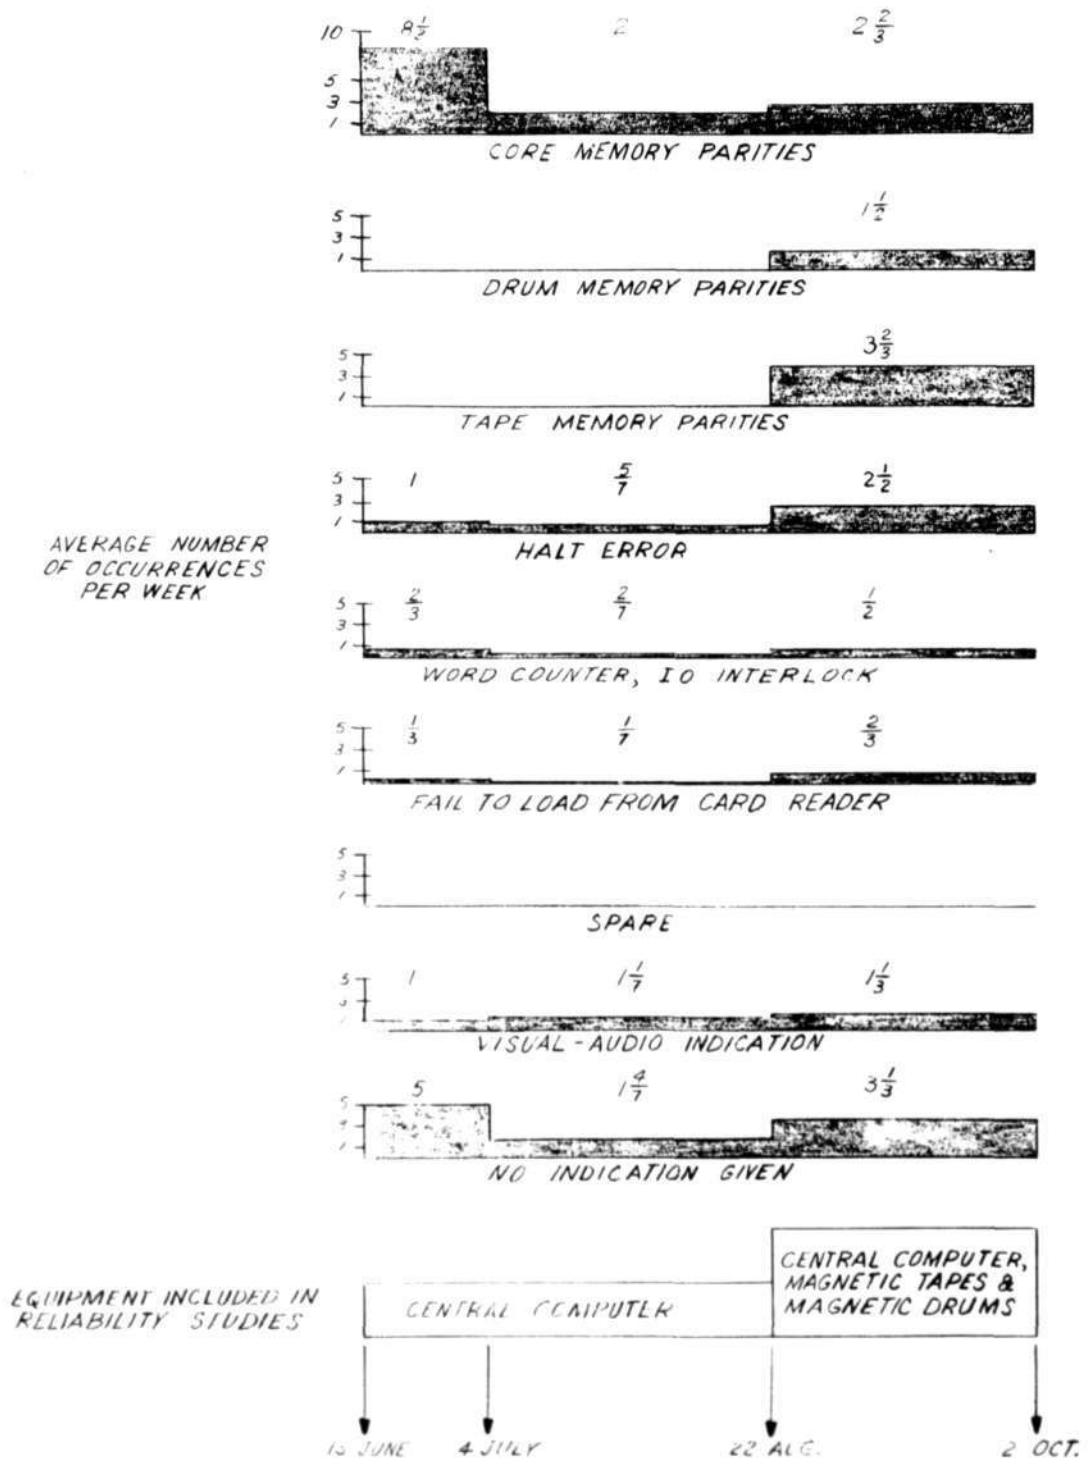
FIG. 3

Four of the failures (2 drum parities and 2 halt errors) were unexplained, but operator error was the most reasonable explanation for their occurrence. One unexplained core memory parity occurred. Also, a tape unit failed to make the transition from high-speed to low-speed rewind. Seven minutes were lost when tape parity errors were noted. A possible explanation for the tape parities is that they occurred near the end of tape where dirt and tape damage are most likely to cause trouble.

UNEXPLAINED FAILURES IN AN/FSQ-7 (XD-1),
13 JUNE 1955-2 OCTOBER 1955
