Report 2844

CONSTRUCTION AND OPERATION OF A HOT-CORROSION TEST FACILITY

Harvey von E. Doering and Paul A. Bergman

March 1969

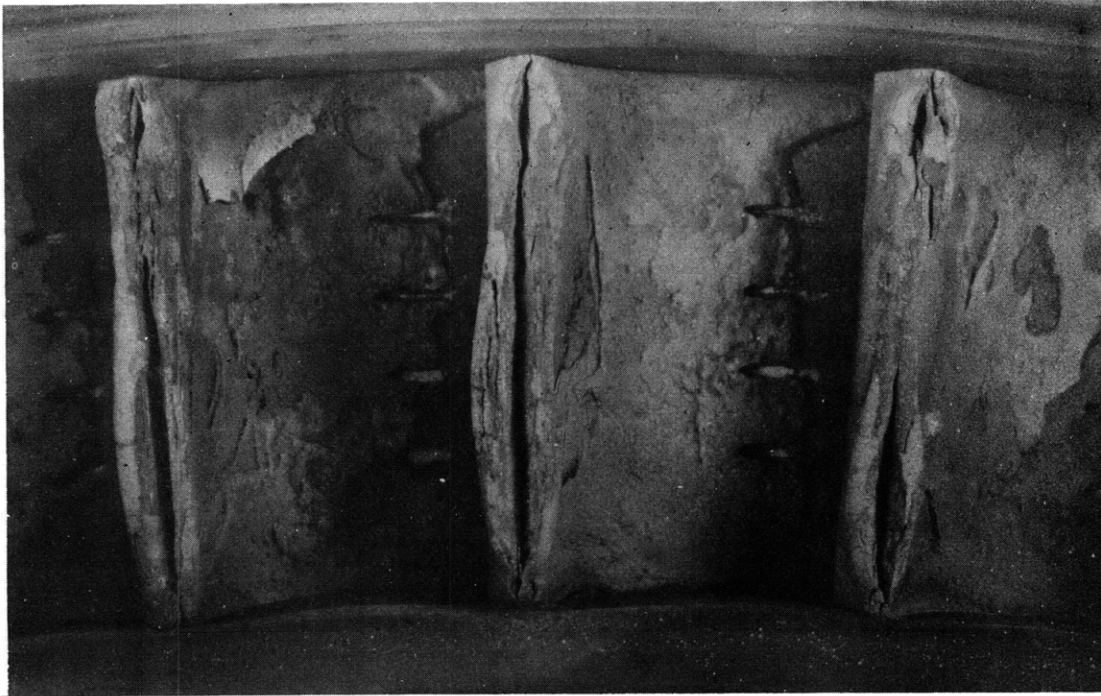
Figure 1

Note: The leading edges of 1st stage nozzle vanes show considerable swelling and cracking.

Severe Hot Corrosion on AMS5391A

The ingestion of sea salt by gas-turbine engines operating in marine environments can lead to corrosion of hot section components, particularly turbine vanes (nozzles) and blades (buckets). A typical corroded part from a commercial test engine, illustrated in Figure 1, and many other cases of similar severe corrosion have been documented in the open literature.^{1,2} This attack has been identified as sulfidation, which is a form of hot corrosion.

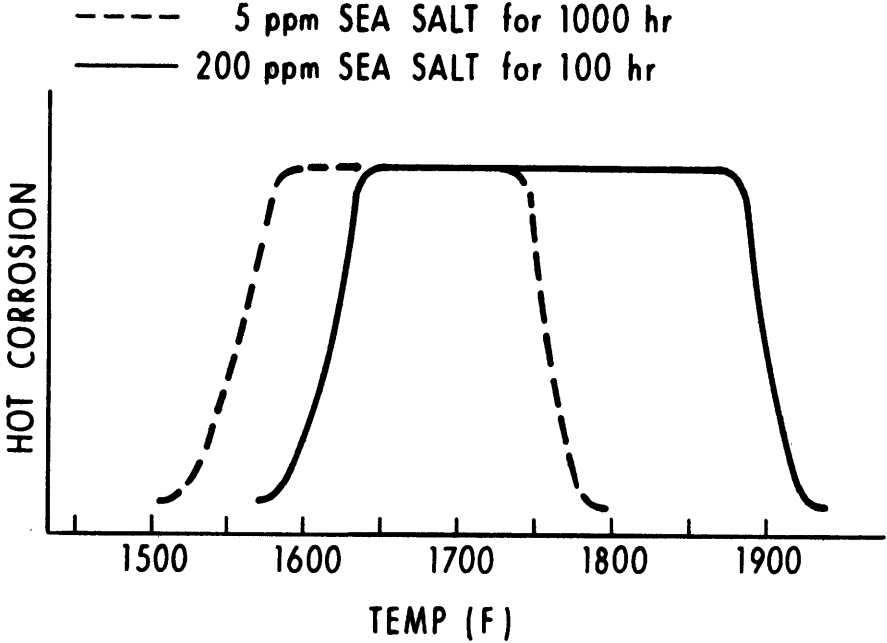
Figure 15

Temperature Range of Hot Corrosion For Two Test Conditions

For tests of 5 ppm sea salt / 1000 hours, the temperature range of hot corrosion is about 1525° to 1800° F (the upper temperature limit is alloy dependent) as contrasted to about 1625° to 1900° F for 200 ppm sea salt/100-hour tests, as illustrated in Figure 15. Apparently, hot corrosion occurs at lower temperatures in the 5 ppm sea-salt test due to longer test times. Undoubtedly, corrosion would also occur at 200 ppm sea salt for periods of time longer than 100 hours. The upper temperature limit of corrosion is about 100° F higher for the 200 ppm sea-salt test due to a higher vaporization/condensation temperature of sodium sulfate at higher salt concentrations. Thus, care must be taken in designing and interpreting the "accelerated test." At low temperatures (e. g. , 1600° F), hot corrosion may not occur because of the short test times. At high temperatures (e. g. , 1800° to 1900° F) with high salt concentrations, a severe hot corrosion reaction may take place. However, only oxidation, or an "accelerated oxidation" aggravated by salt vapors, would occur for lower and more realistic sea-salt concentrations.
