CYCLIC LOADING STUDIES
OF TWO COMPOSITE CONSTRUCTION MODELS

STRUCTURAL MECHANICS LABORATORY
RESEARCH AND DEVELOPMENT REPORT

August 1964

Report 1853

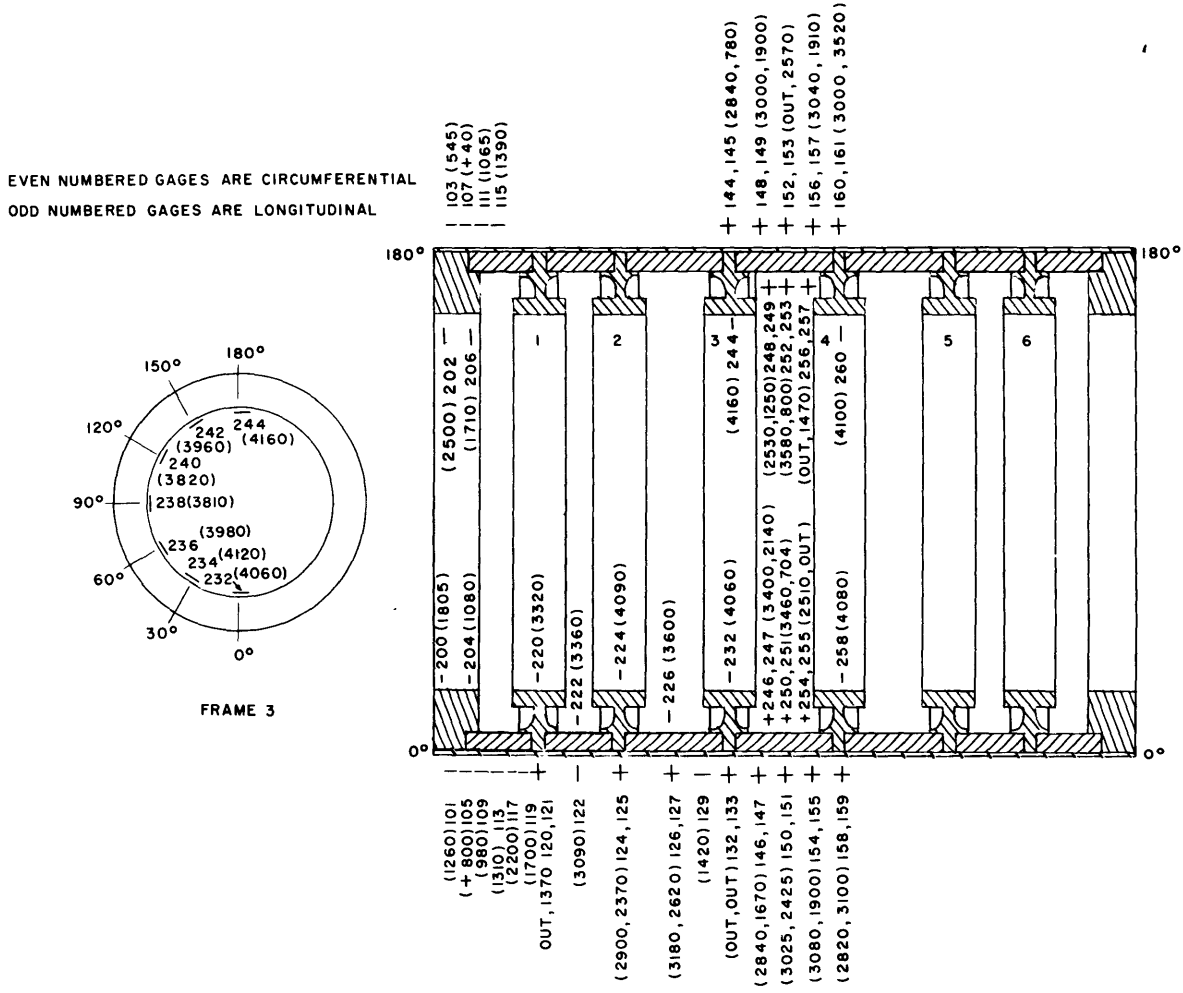
Figure 3a - Model DSRV-1A

Figure 3 - Strain Gage Locations and Strains at 4450 PSI

Prior to cyclic testing, both models were instrumented with foil resistance gages for static loading. The static and fatigue tests were conducted at the Southwest Research Institute (SRI) at San Antonio, Texas. Strain data were recorded while the models were pressurized in the SRI 4-ft pressure tank. Two pressure runs to 3500 psi were made for each model. Figure 3 shows strain gage locations and strains extrapolated to 4450 psi. Next, the models were placed in a 30-in.-diameter tank and subjected to a pressure of 4900 psi, a 10 percent overload. During this test, the light steel jacket on Model DSRV-1F buckled. However, it was decided to continue with the cyclic test of this model and both models were placed in the SRI cyclic tank. The models were filled with oil and surrounded by

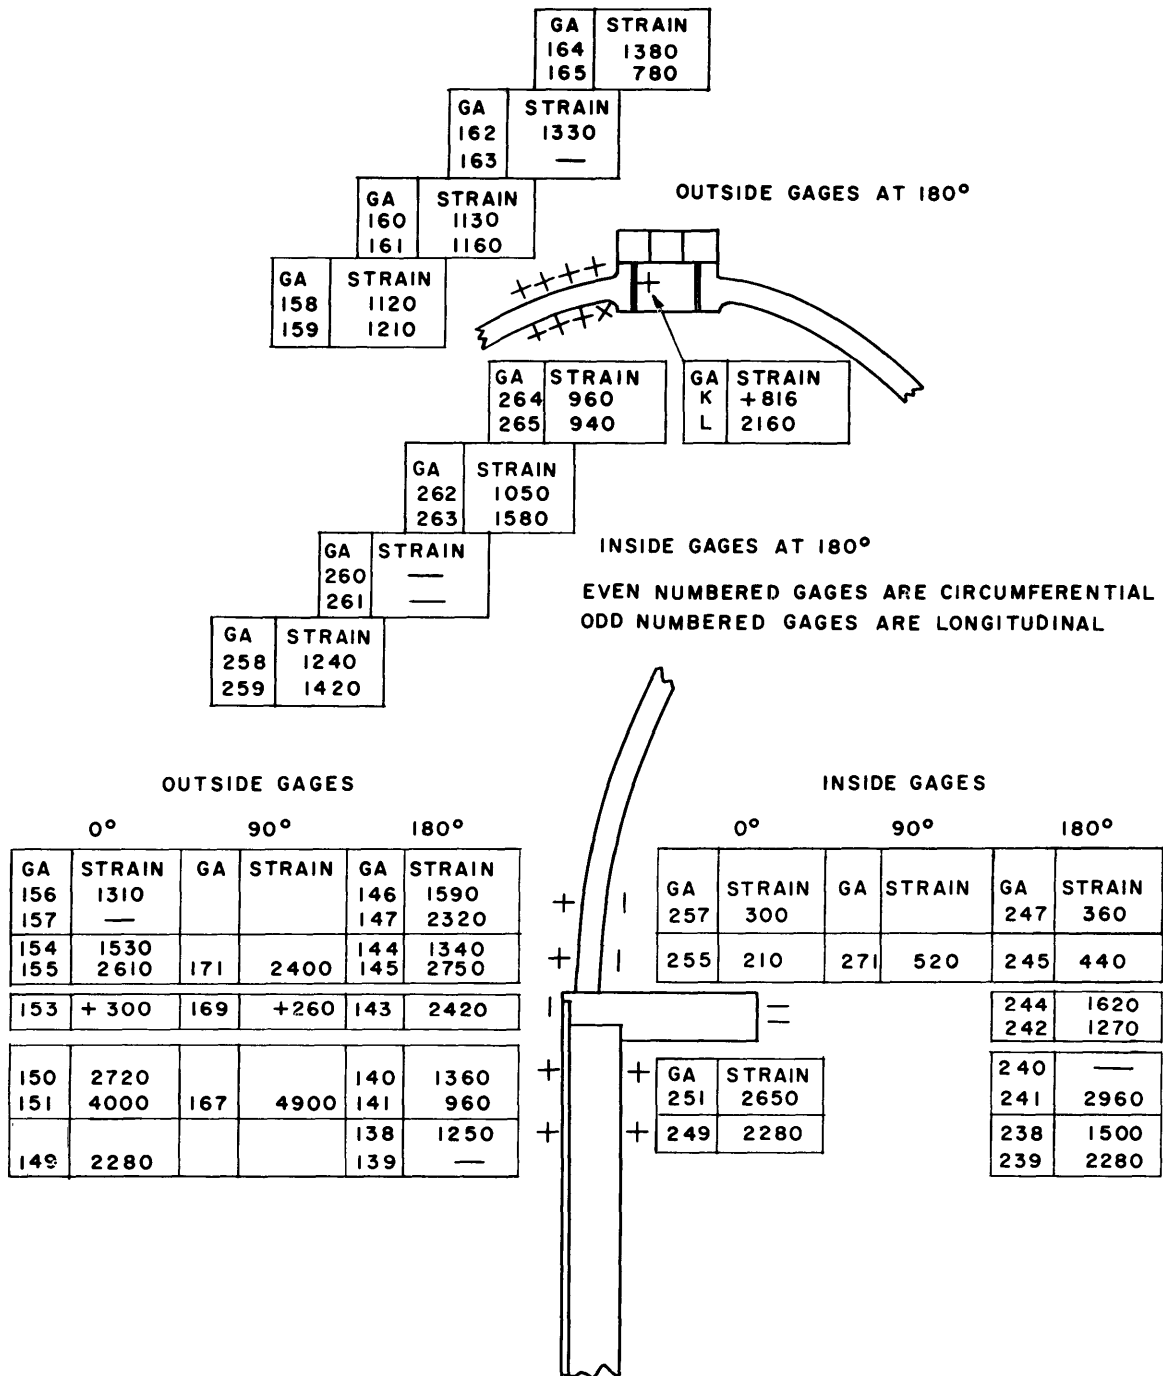
Figure 3b - Model DSRV-1F

OUTSIDE GAGES

90°		180°	
GA	STRAIN	GA	STRAIN
136	4160	134	2840
137	4300	135	3800
GA	STRAIN	GA	STRAIN
131	2320	128	3070
		129	3330
		132	1720
		133	—
126	3050		
127	2560		
124	2840		
125	2460		
123	2680

EVEN NUMBERED GAGES ARE CIRCUMFERENTIAL
ODD NUMBERED GAGES ARE LONGITUDINAL

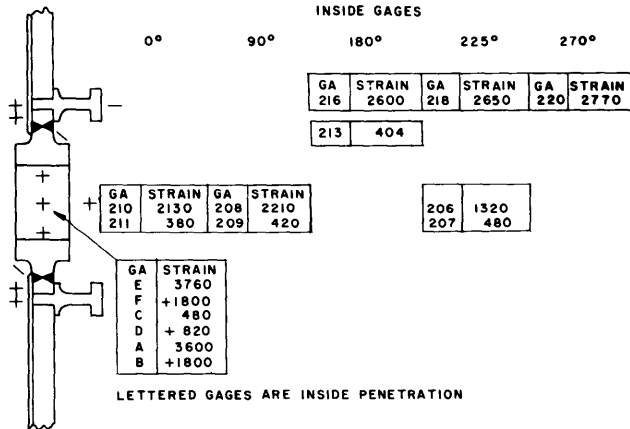
Figure 3c - Model DSRV-1F

OUTSIDE GAGES

0°		90°		180°		225°		270°	
GA	STRAIN	GA	STRAIN	GA	STRAIN	GA	STRAIN	GA	STRAIN
116	2060	118	1860	120	2210	119	—	121	—
117	4000	119	—	121	—	118	1860	120	2210
114	1930								
115	4200								
GA	STRAIN	GA	STRAIN						
110	2020	108	1960						
111	290	109	660						
				106	1730				
				107	830				
		105	875						
		102	—						
		103	280						
		100	2370						
		101	1300

LETTERED GAGES ARE INSIDE PENETRATION
